**BONDURANT**  
ARCHITECTURE

### HURON COVE CONDOMINIUMS 911 HURON COURT

**Site-Visit Date:**  
August 27, 2024

**Report Date:**  
August 29, 2024

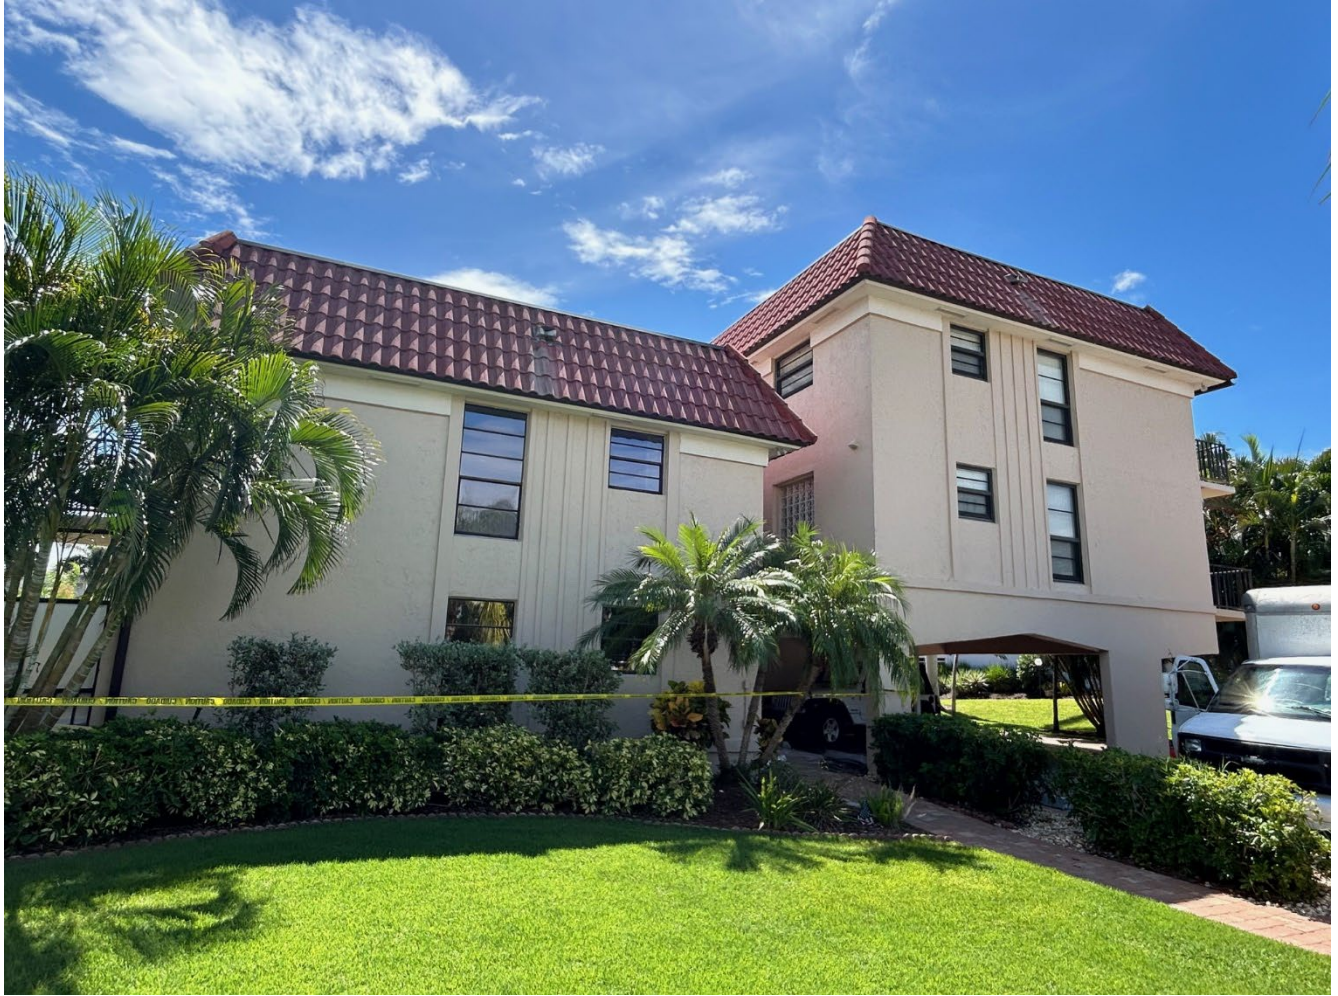
**Front View**

911 Huron Cove has an exterior of cementitious stucco. Exterior is generally in good condition with only a few anomalies observed. See photos below for recommendations regarding some of the conditions noted.
