**Huron Cove Condominium**  
**SIRS Components**  
***Marco Island, FL***

Report #: 53605-0  
Beginning: January 1, 2025  
Expires: December 31, 2025

**RESERVE STUDY**  
**"Full"**

December 3, 2024

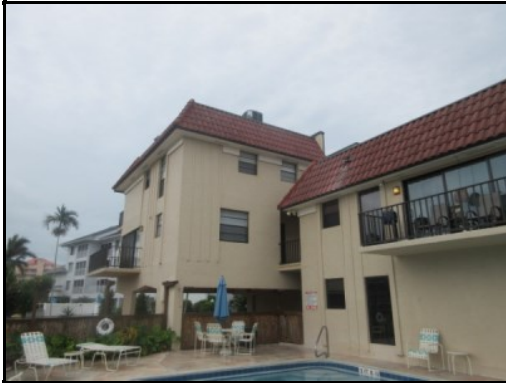
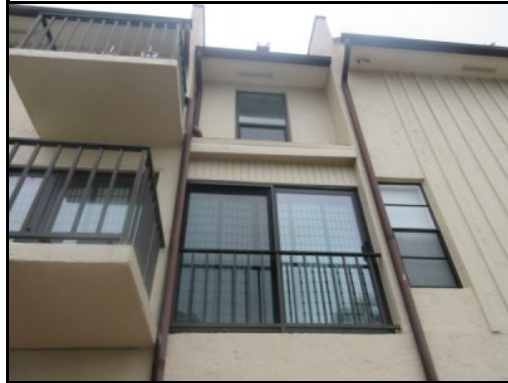
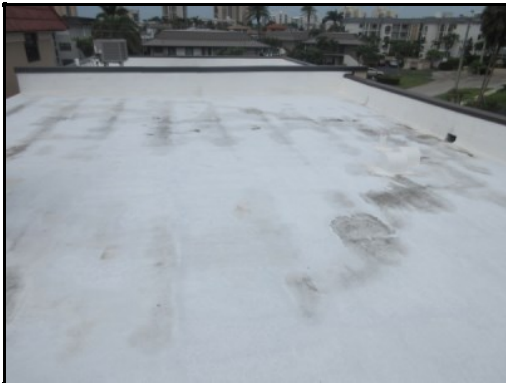
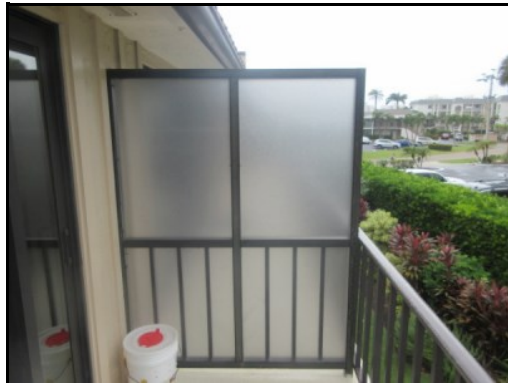
During our site visit on 11/22/2024, we started with a brief meeting with Nick Fiorucci and John Meuser. We thank them for their assistance and input during this process. During our inspection, we visually inspected all common areas, amenities, and other components that are the responsibility of the Client. Please refer to the Component Details section at the end of this document for additional photos, observations and other information regarding each component.
