April 12, 2023

Les Falls Condominium Association  
c/o John Zimmerman, Vice President  
870 S Collier Blvd  
Marco Island, FL 34145

## **Phase 1 Milestone Inspection Report at Les Falls Condominium in Marco Island, FL**

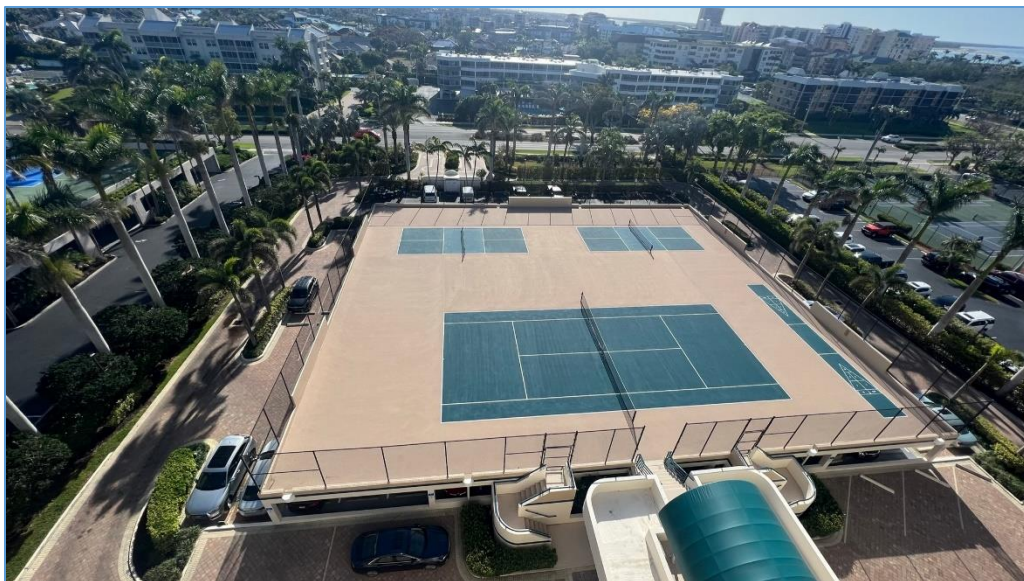
**Tennis Court:** The tennis court is located on top of the garage and therefore acts as the roof of the garage. The tennis court has perimeter scuppers to allow draining of water. The perimeter scuppers appear to be functioning due to no evidence of ponding water (stains). Some perimeter scuppers are blocked with debris. The perimeter chain link fence acts as the guard for the structure. The connection of the chain link fence posts with the concrete knee wall was exhibiting corrosion throughout. Two sets of stairs at the north and south of the porte-cochere allow access to the tennis court from the grade level. Both sets of stairs were acoustically sounded and deterioration of concrete was noted through this sounding. Expansion joints separate the stairs from the tennis court and are concealed by aluminum cover plates attached to both the tennis court and top stair landing, with one side in a slotted hole to allow for movement.

*Figure 11: Tennis Court*
