# ***W.J. JOHNSON & ASSOCIATES***

September 28, 2022

Subject: **Limited Structural Review and Wind Mitigation Report  
Sandcastle I Condominium  
Project #: 05128.07**

Subject:     **HB-4D Phase I Structural Inspection**  
              **Sandcastle I Condominium**  
              **730 south Collier Boulevard**  
              **Marco Island, FL**  
              **Project #: 05128.09**

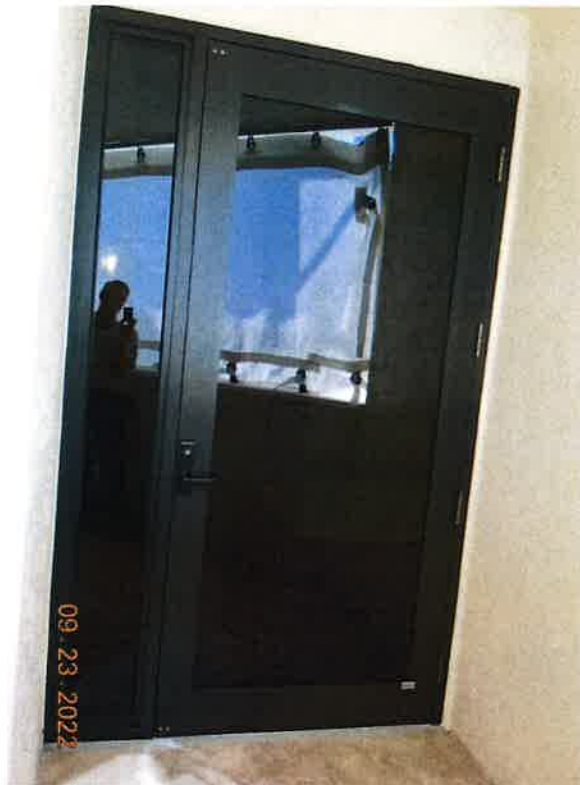
**Common Area Impact Rated Pass Doors**

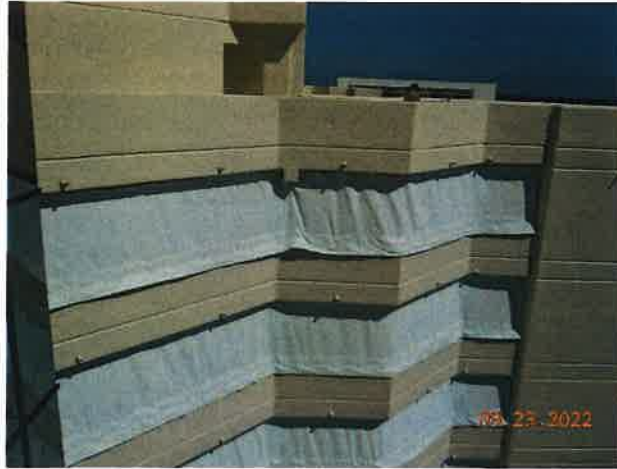
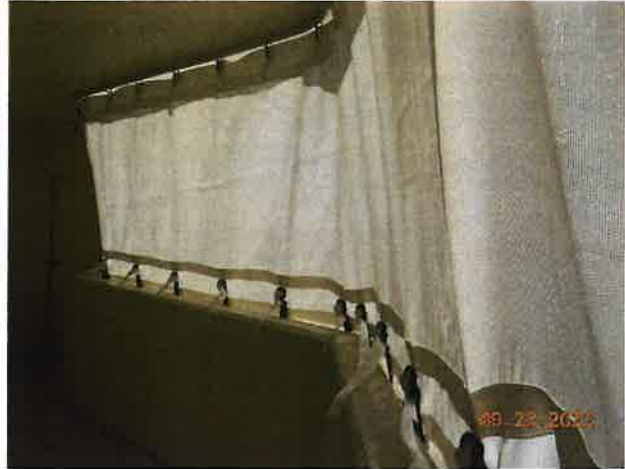
Each level of the East side of the building is serviced by an exterior walkway. These areas are susceptible to moisture damage during a tropical rain event. These areas are now being protected by hurricane curtains manually attached to the structure. The first-floor level displays evidence of moisture infiltration from previous events.

**New Hurricane Curtains Being Installed Prior to Hurricane Ian**
