# **W.J. JOHNSON & ASSOCIATES**

Subject: **HB-4D Phase One Structural Inspection**  
**South Seas East Condominium Apartments of Marco Island, Inc.**  
**651 Seaview Ct. Building B**  
**Marco Island, FL**  
**Project #: 22069.04**

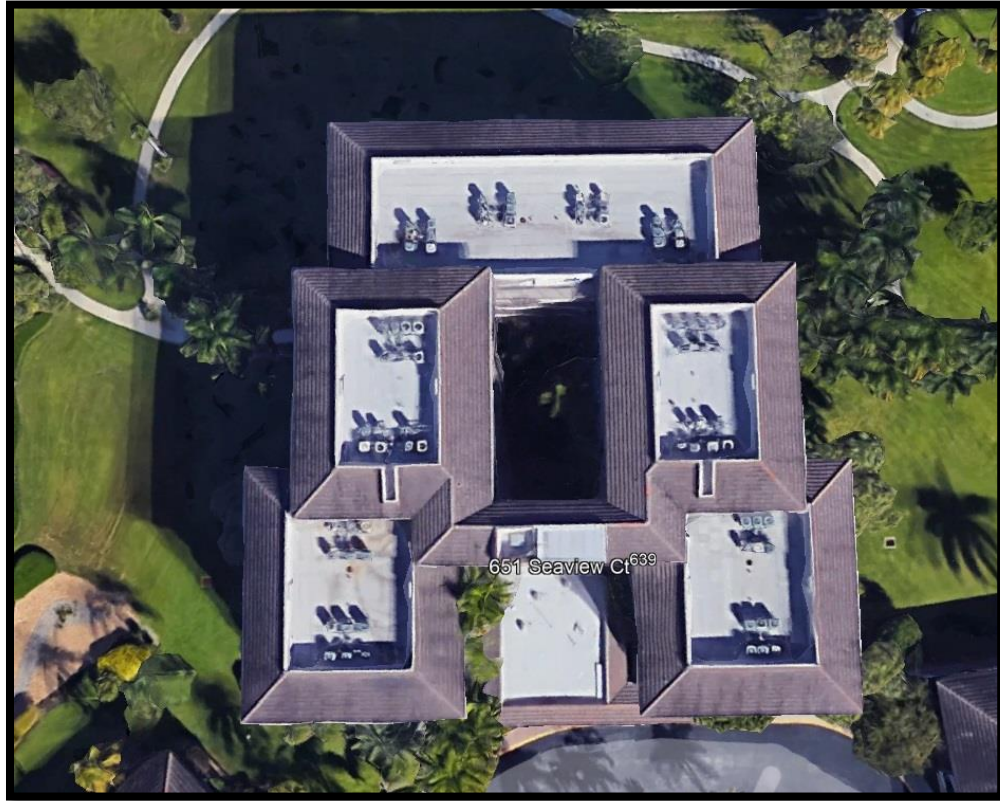
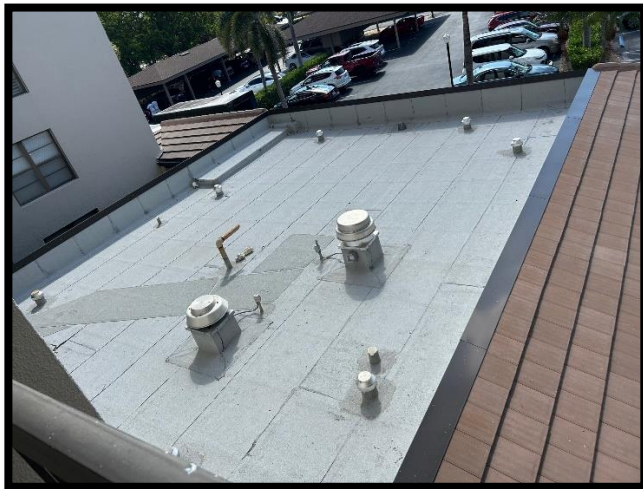
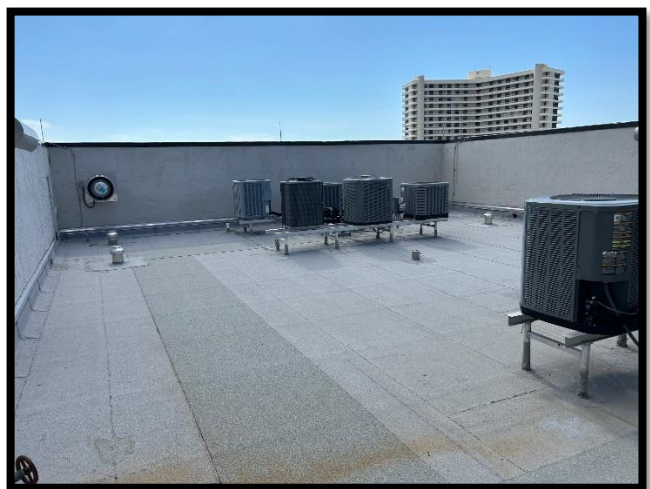
**Roof Drains and Scuppers**

The roof system is a modified bitumen system installed at all areas in 2023 under permit #ROOF-22-07867. This permit is listed as expired. This includes the flat roof and the pitched concrete tile mansard sections. The roof is in good condition. The HVAC condensers are supported by structural aluminum stands in good condition.
