# **W.J. JOHNSON & ASSOCIATES**

July 18, 2024

Subject: **Phase One Structural Inspection  
South Seas North Condominium Apartments  
Marco Island, FL  
Project #: 24024.04**

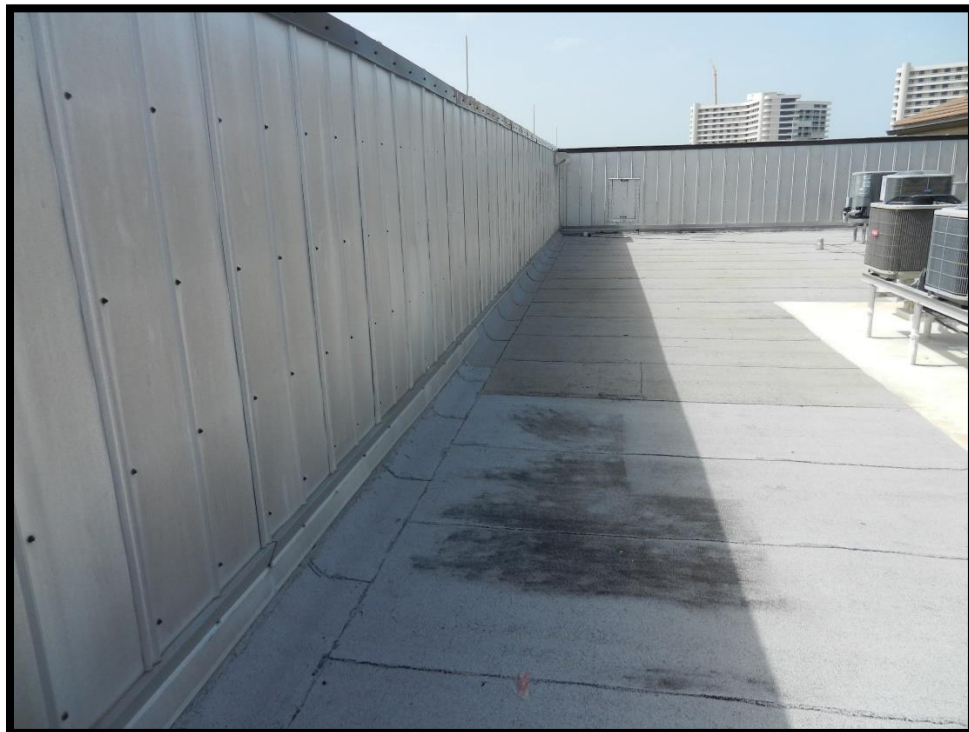
**East Wing Roof**

The roof system is a modified bitumen system installed at all areas in 2021 except for the East wing, which is in good condition. The façade tile was replaced in in 2023. The façade roof is supported by a wood truss system in good condition. The wood truss system is double strapped to the structural system.
