### STEVENS LANDING CONDOMINIUMS

**100, 200, & 300**

**STEVENS LANDING DR.**

Bondurant Architecture, LLC ("BA") conducted a Phase One Structural Assessment of the five-story residential condominium buildings, located at 100, 200, and 300 Stevens Landing Dr., in Marco Island, Florida ("Subject Property"). The Subject Property was originally constructed in 1986.

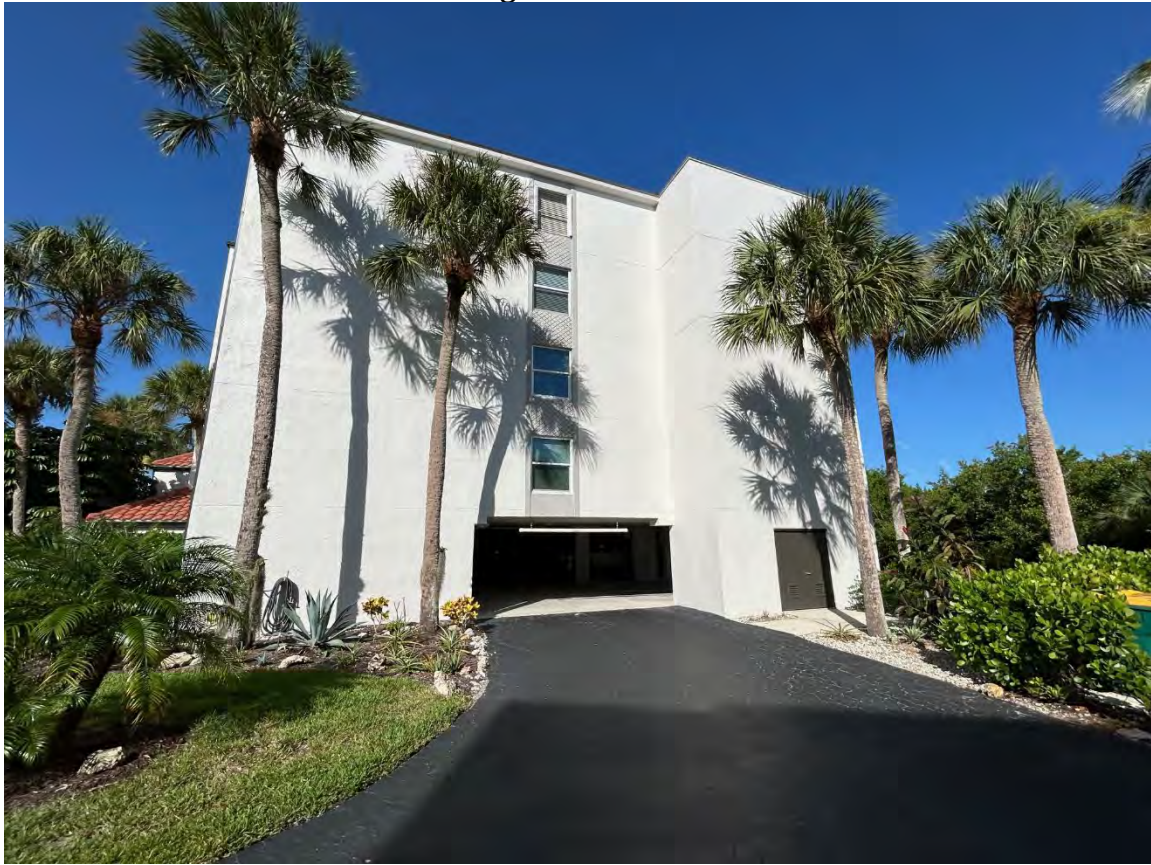
**Right Side View**

100 Stevens Landing Drive has an exterior of cementitious stucco. Exterior is generally in excellent condition with no observed hairline cracks in the stucco. Note other conditions on the exterior needing to be addressed. See photos below for recommendations.

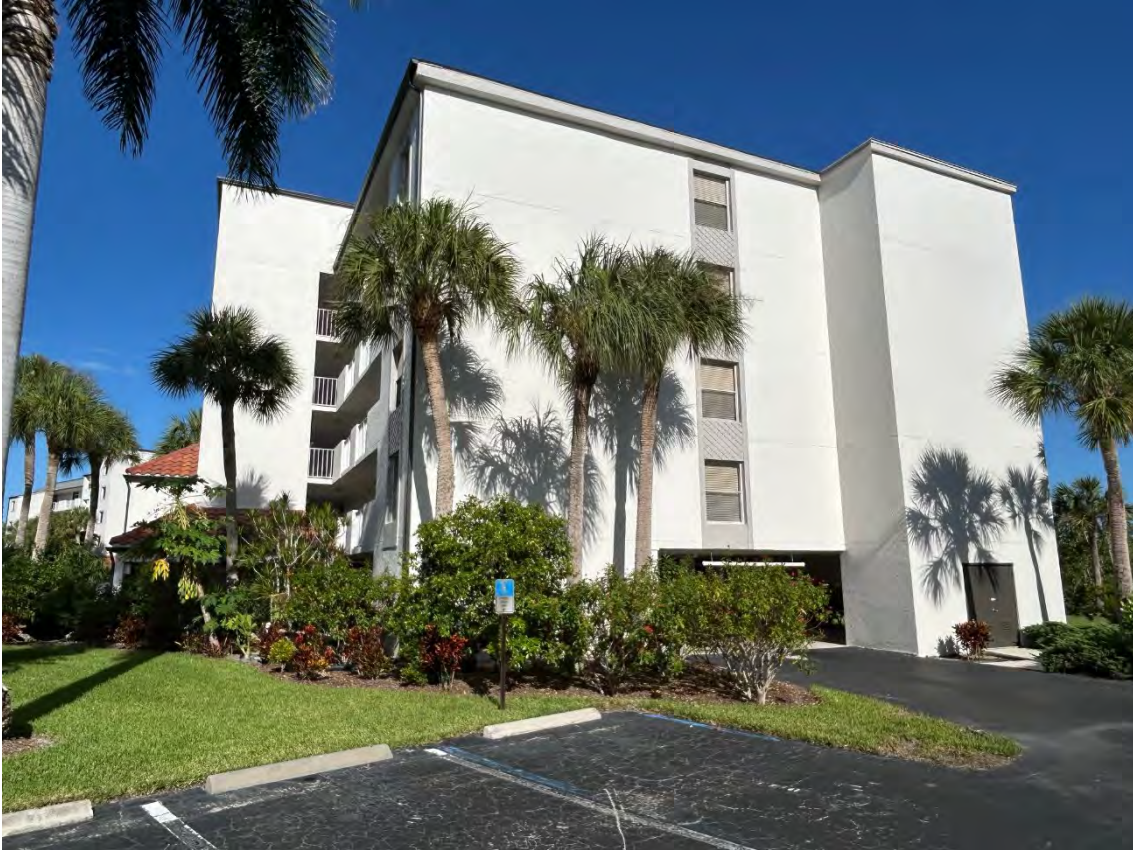
**Right Side View**

200 Stevens Landing Dr has an exterior of cementitious stucco. Exterior is generally in excellent condition with no observed hairline cracks in the stucco. See photos below for recommendations

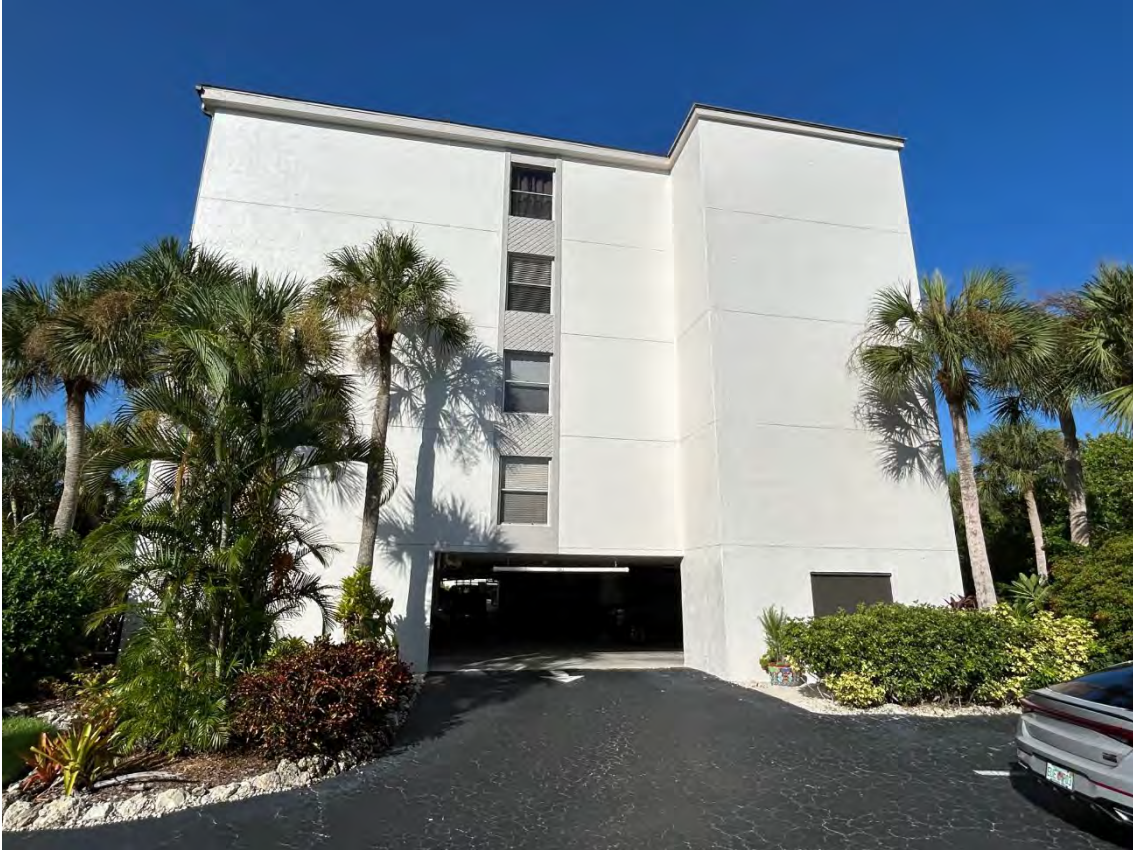
**Right Side View**

300 Stevens Landing Drive has an exterior of cementitious stucco. Exterior is generally in excellent condition with no observed hairline cracks in the stucco. See photos below for additional recommendations.

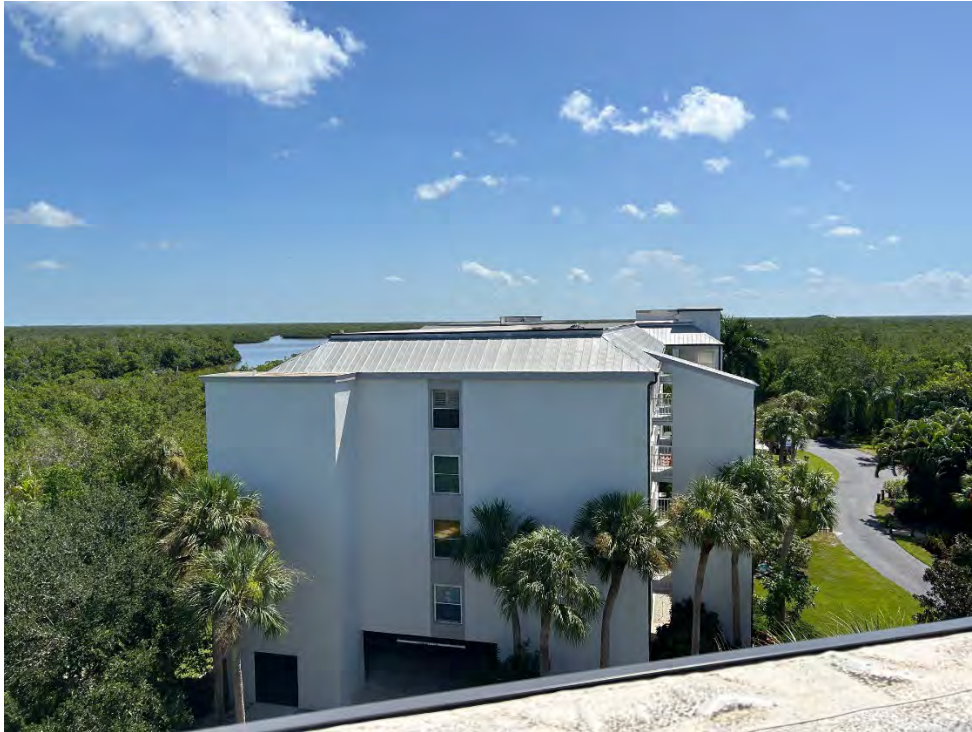
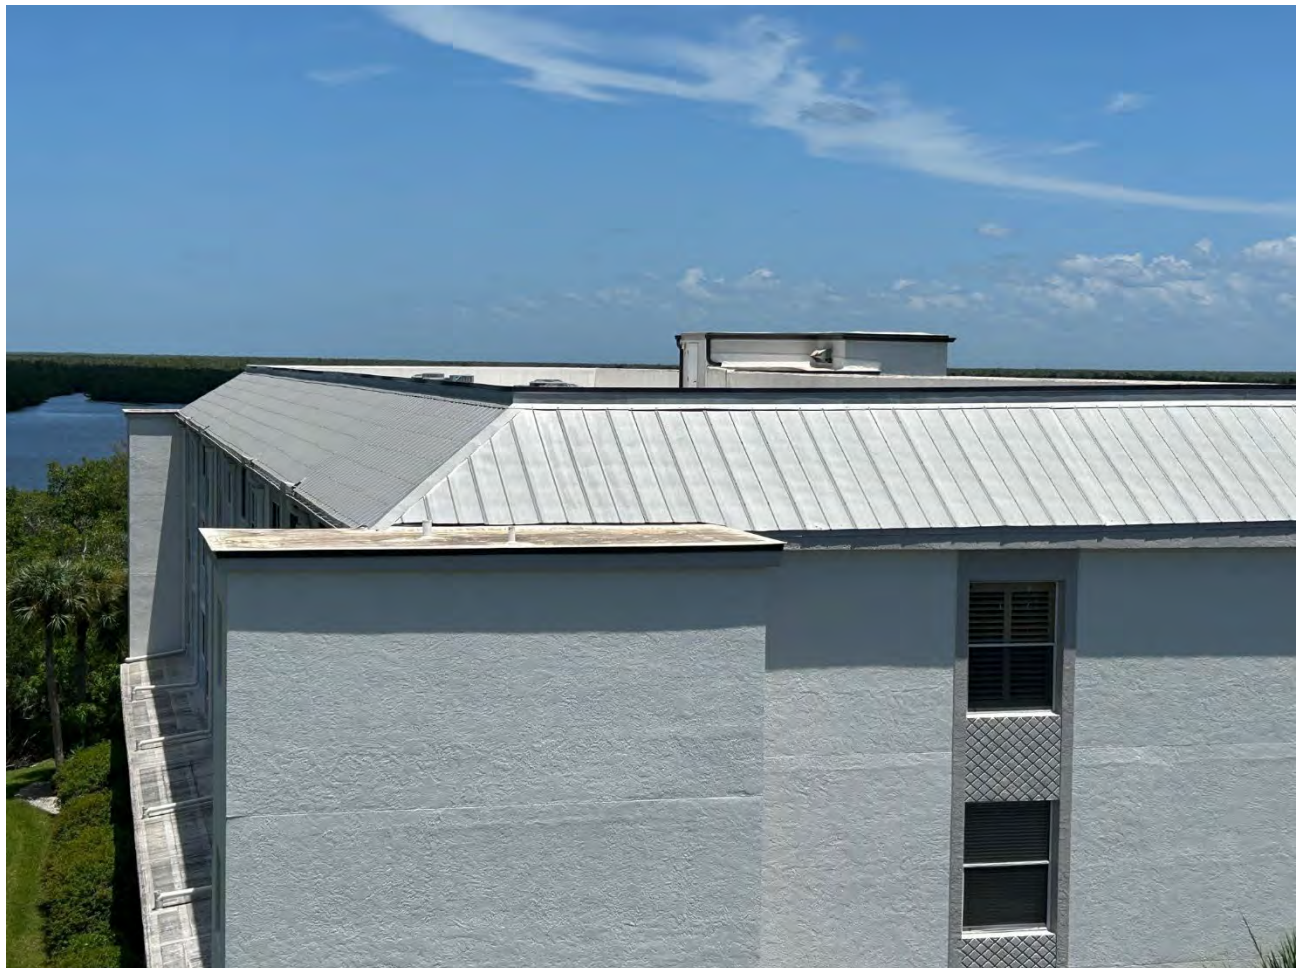
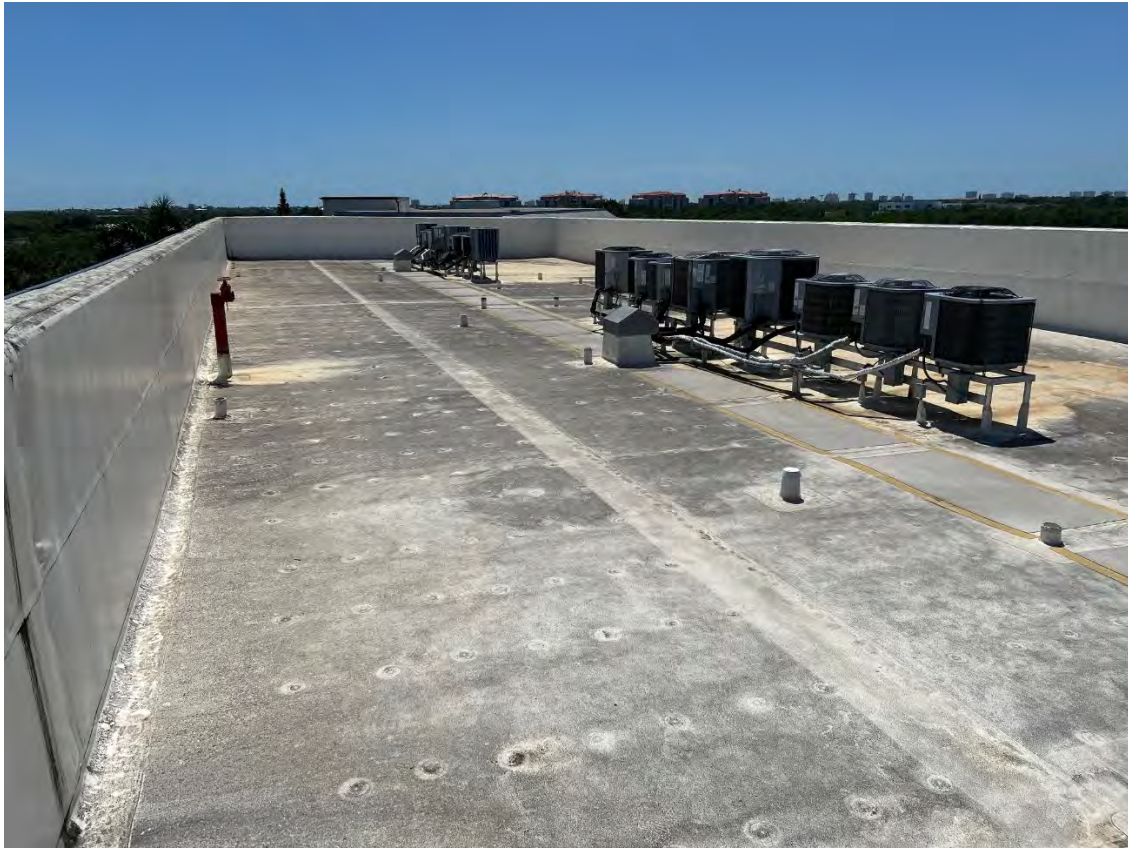
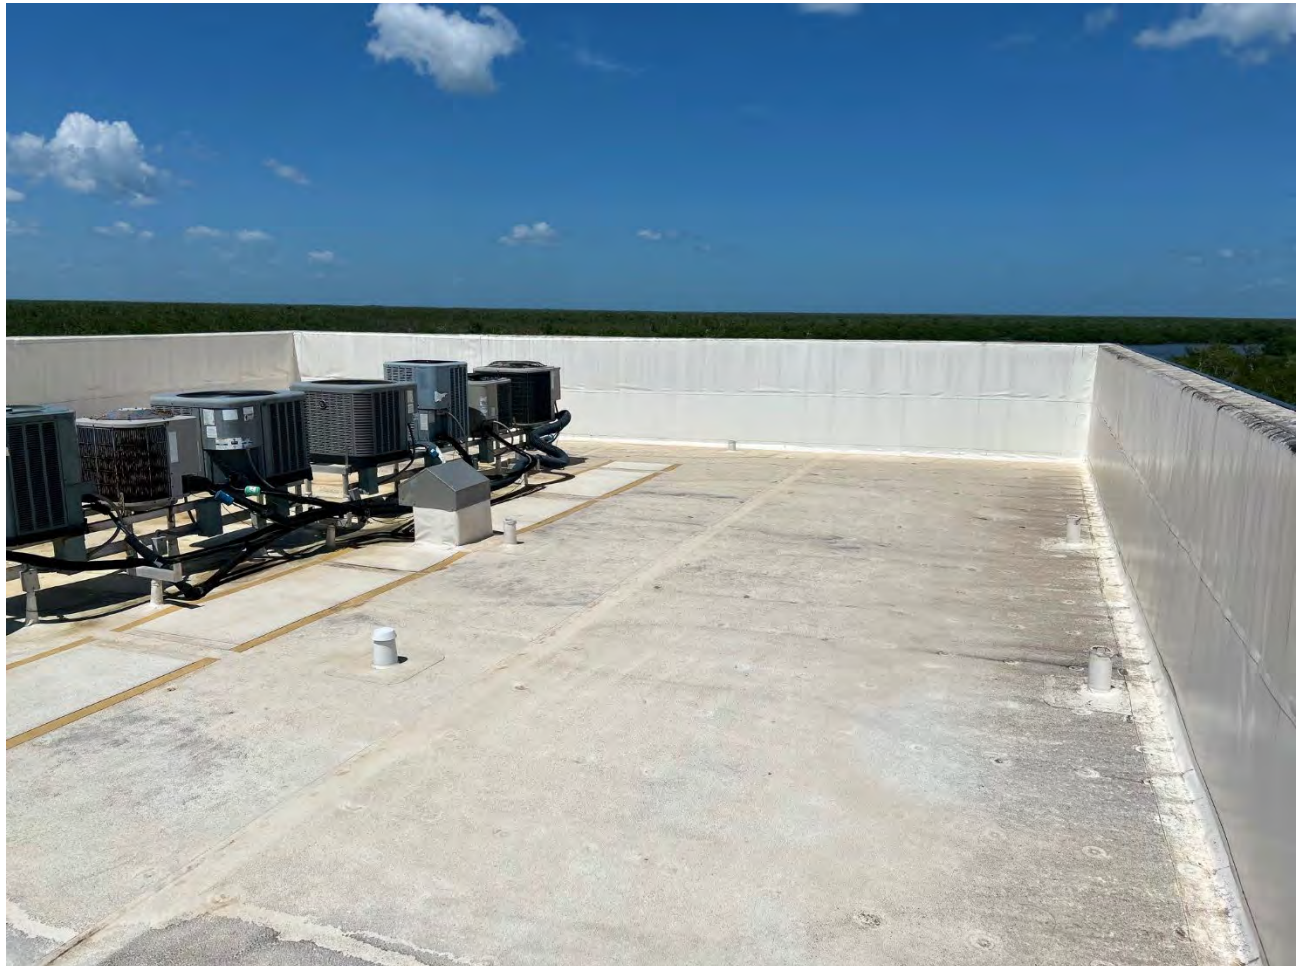
## Typical Views of Roof Systems

Two locations on the Roof of the 300 building had downspouts emptying directly onto roof surface. Suggest installing a wear layer under the ends of the downspouts to protect roof surface.
