# JMC Engineering Inc.

VILLE DE MARCO WEST, A CONDOMINIUM, INC.  
1200-1208 Edington Place  
Marco Island, FL 34145

Reference: MILESTONE PHASE 1 INSPECTION REPORT  
Ville De Marco West, A Condominium, Inc.  
JMC Project Number: 119BPM.12

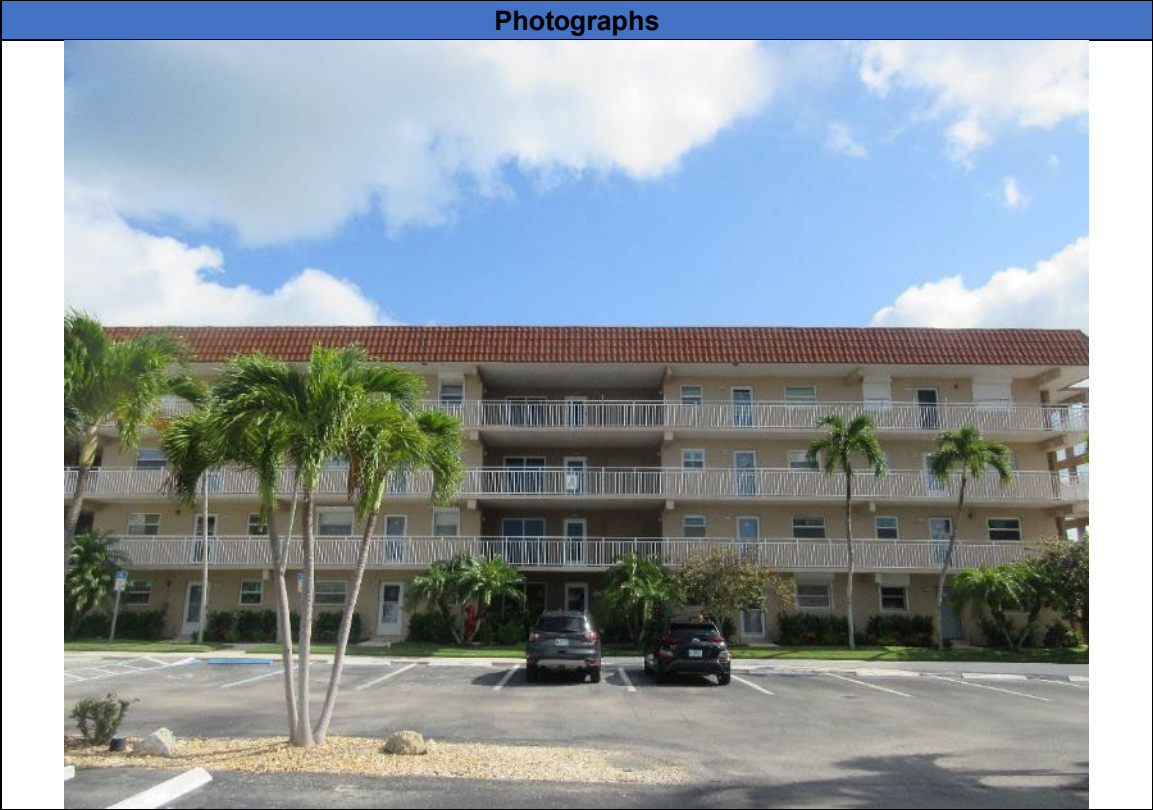
Photo 1. Front Elevation of Building A

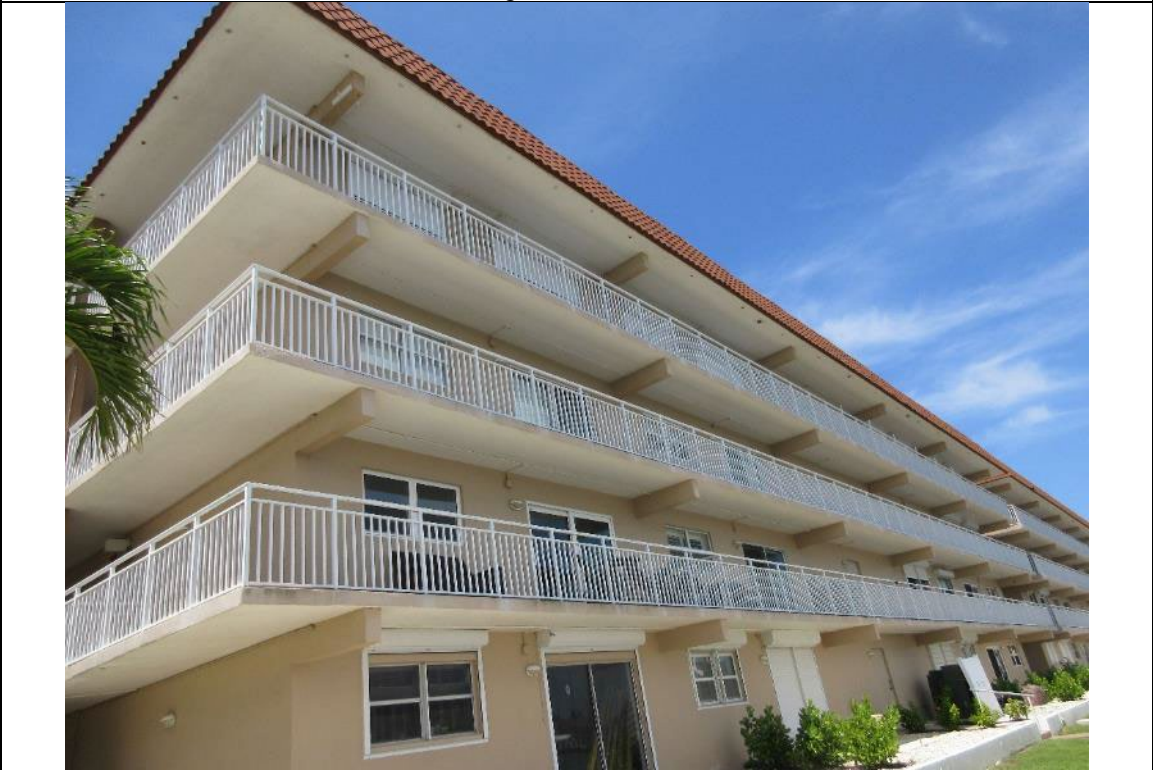
Photo 2. Rear Elevation Building A Overview

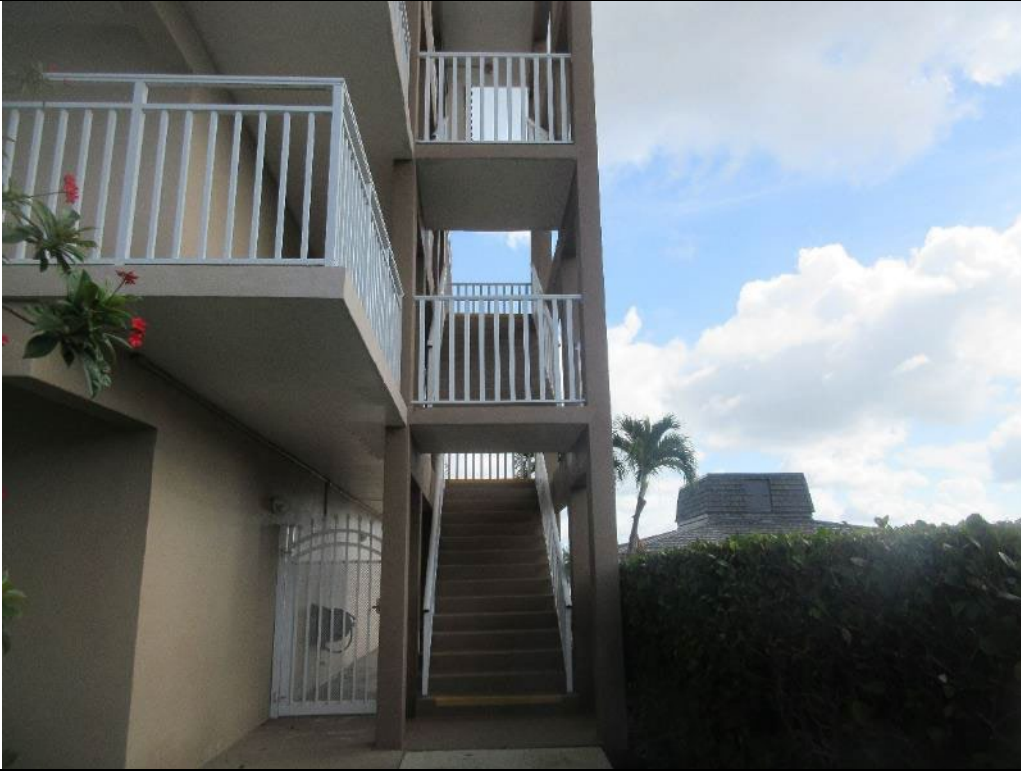
Photo 3. Typical Overview East Side Stair Tower

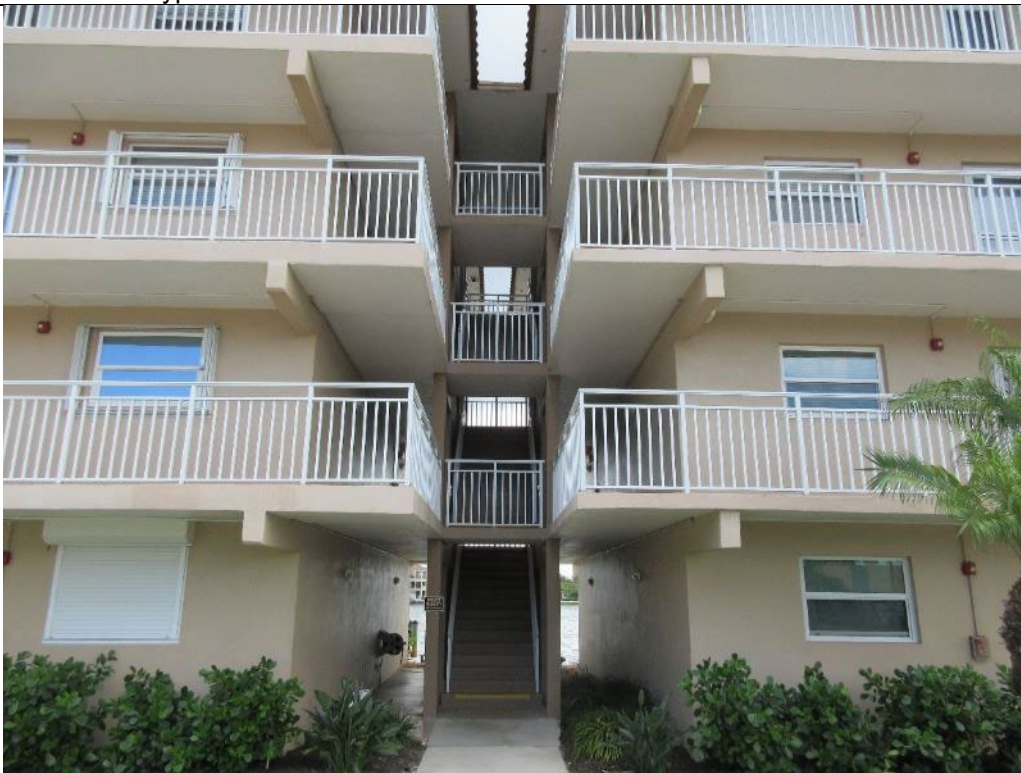
Photo 4. Overview Shared Stair Two and Combined Walkways at Buildings A and B

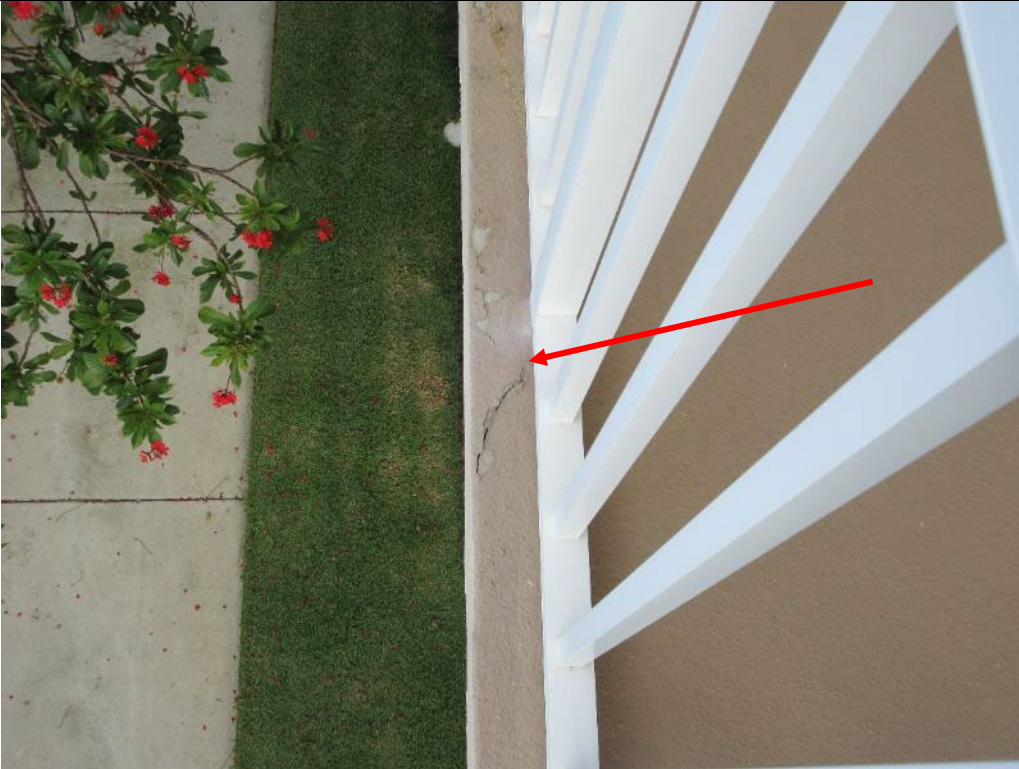
Photo 9. Cracked and Spalling Concrete at Railing Post Pocket and Failed Deck Coating

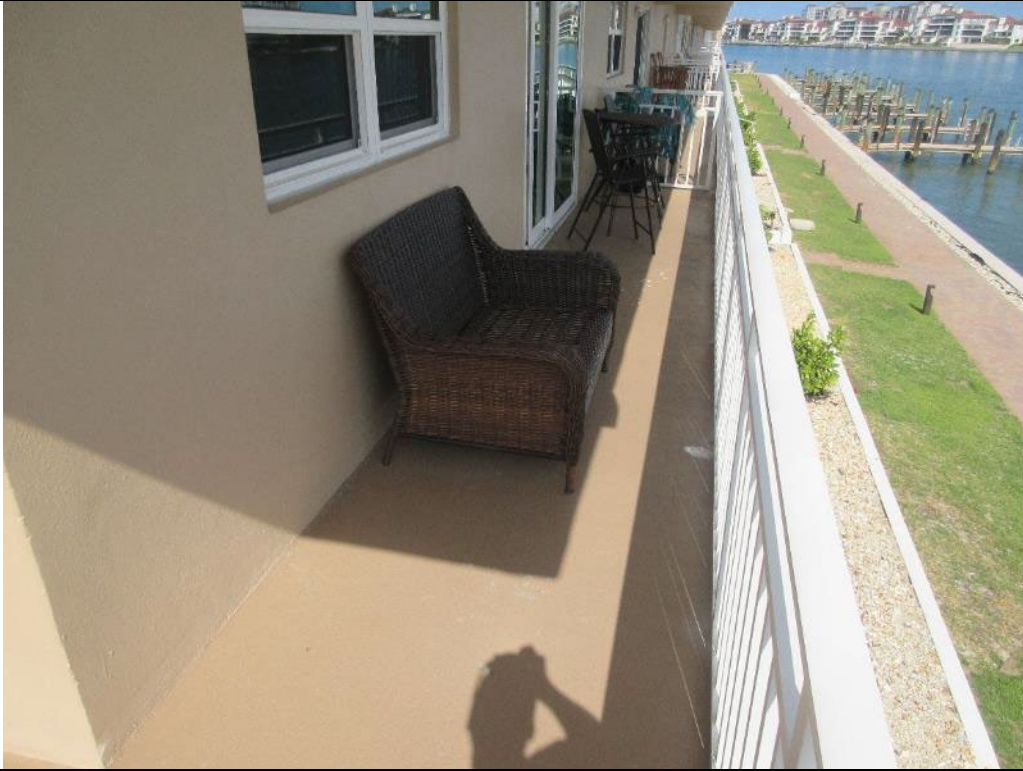
Photo 13. Typical Balcony Overview (Unit A201)

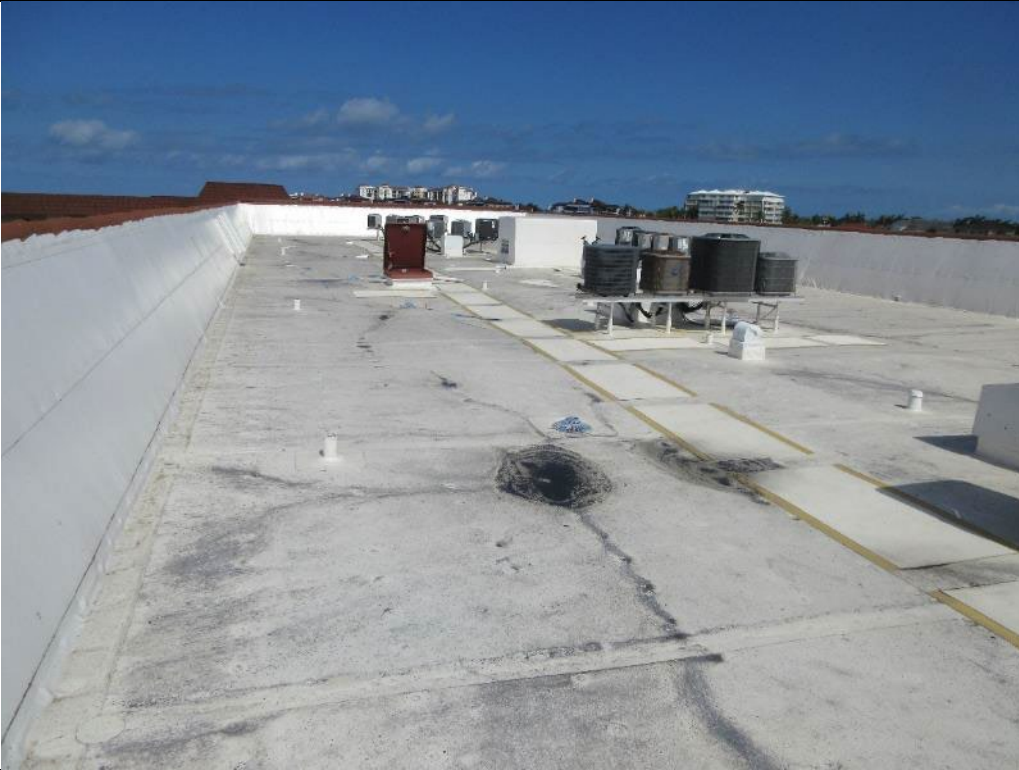
Photo 20. Typical Overview TPO Roof

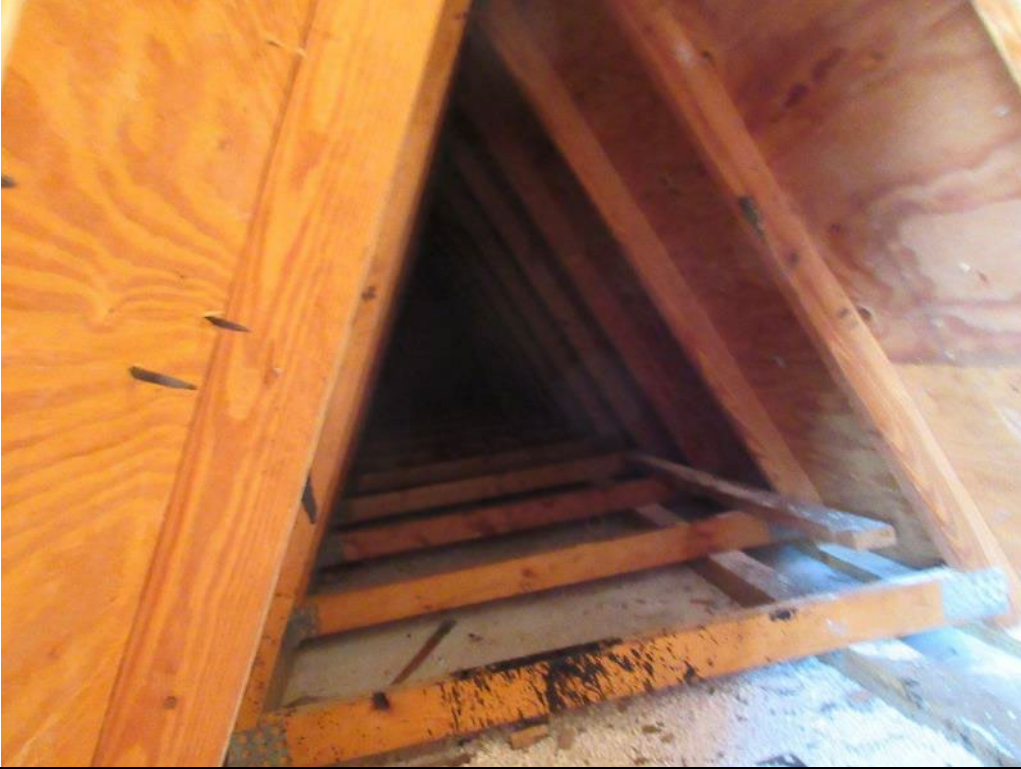
Photo 21. Typical Mansard Roof Trusses

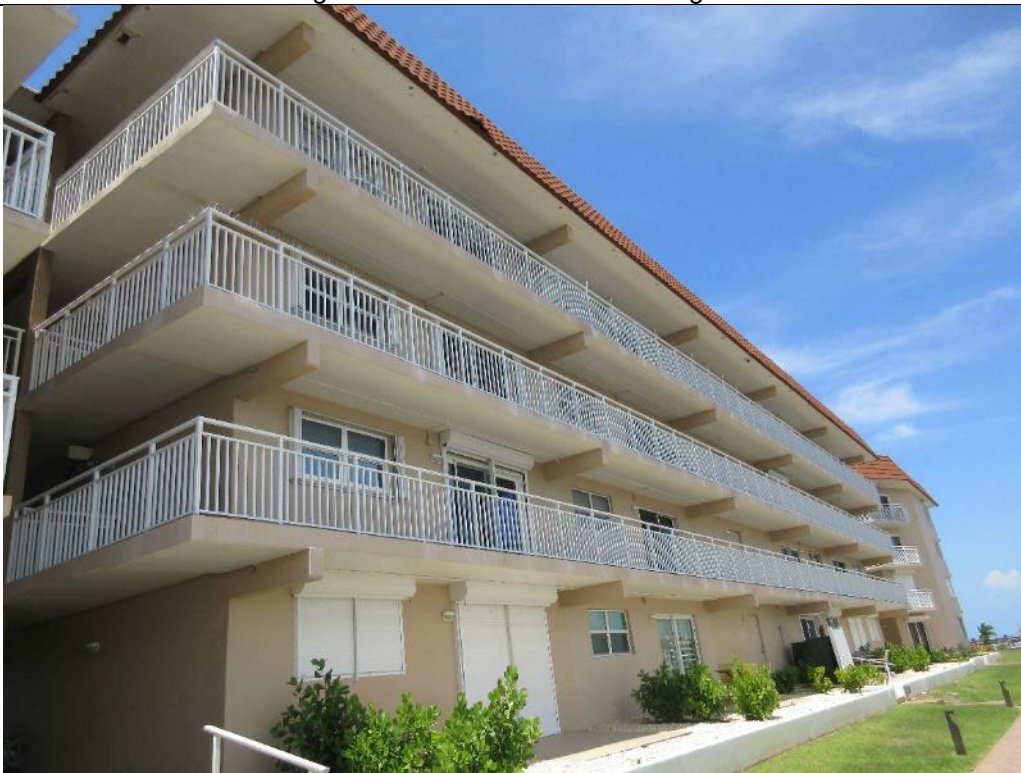
Photo 24. Rear Elevation Building B Overview

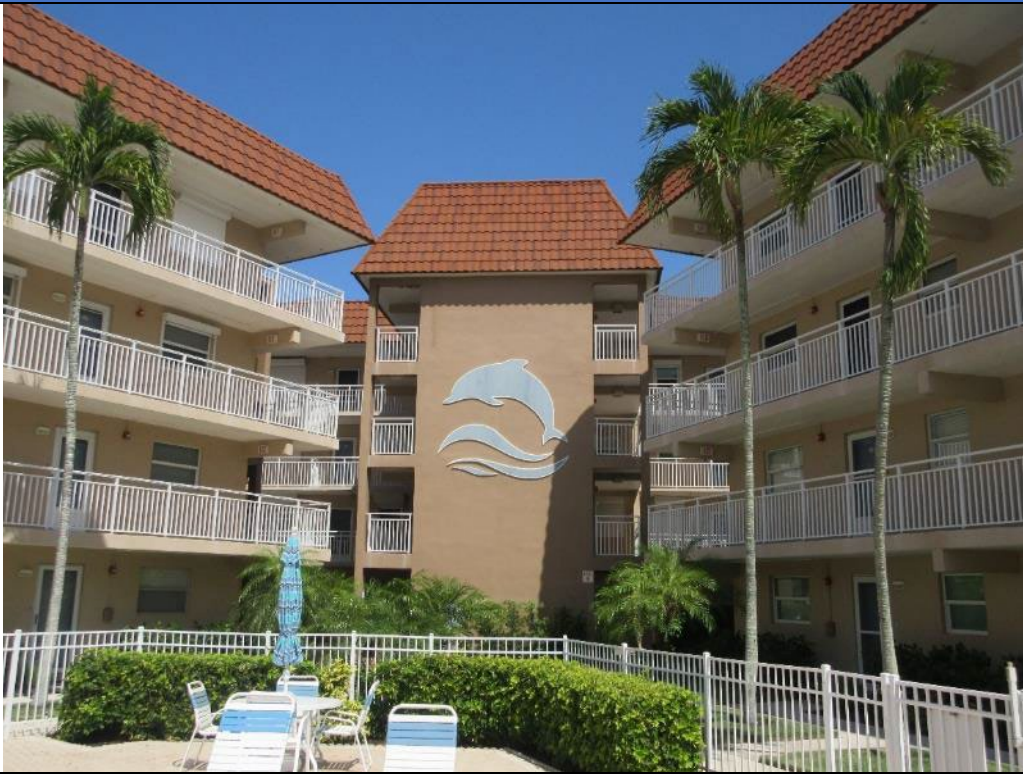
Photo 35. Building C Front Elevation (Building B on Right Building D on Left)

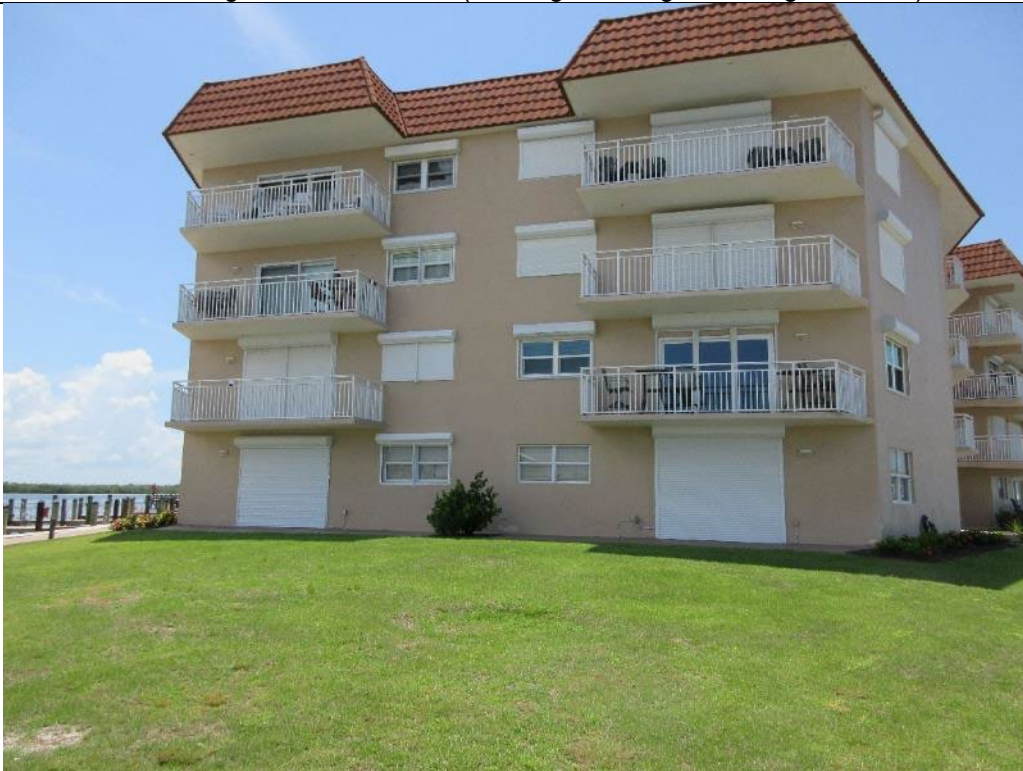
Photo 36. Overview Rear Building C

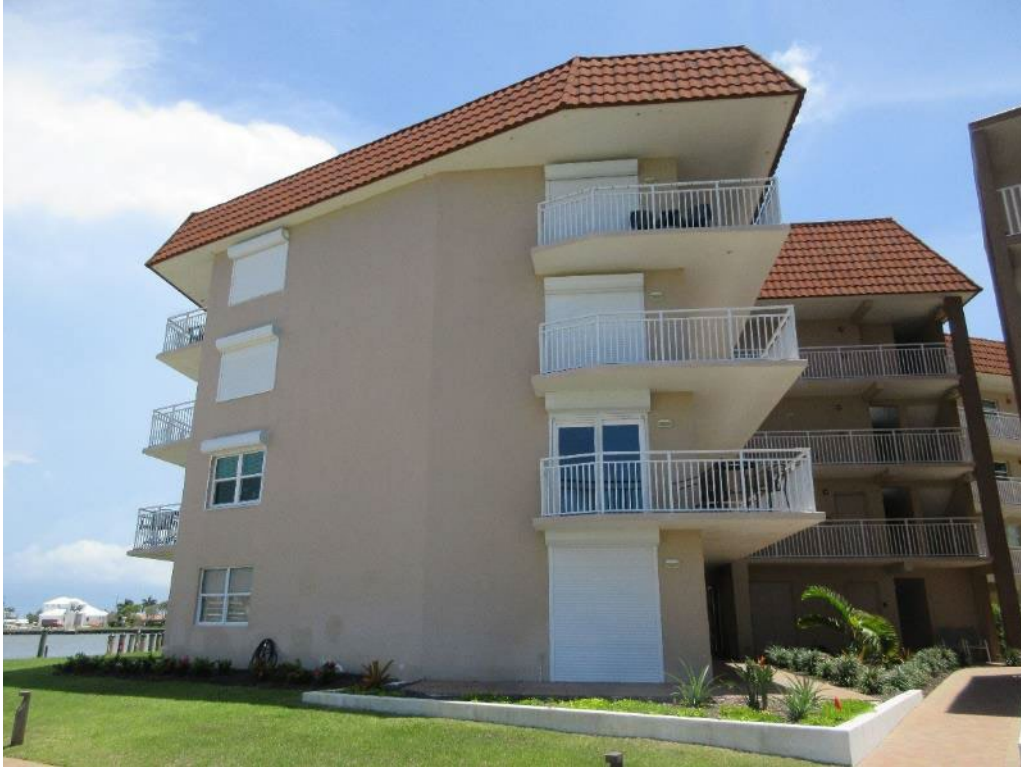
Photo 37. Overview W Elevation Building C Typical Side Balcony and Walkway

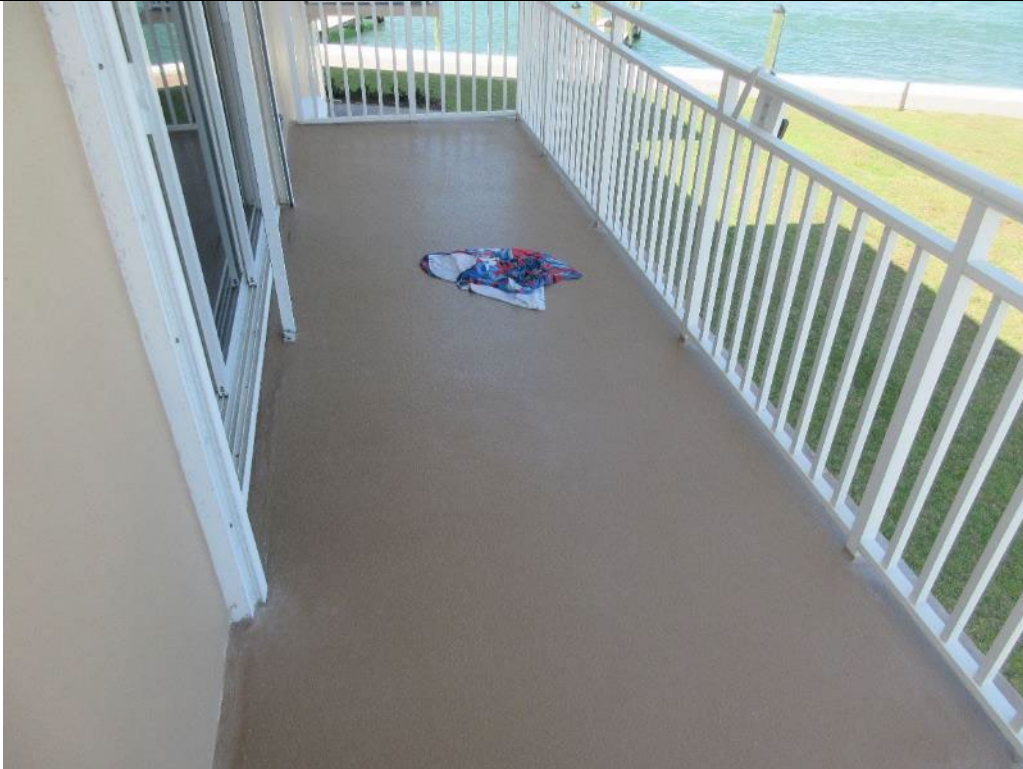
Photo 39. Unit C201 Rear Balcony Overview

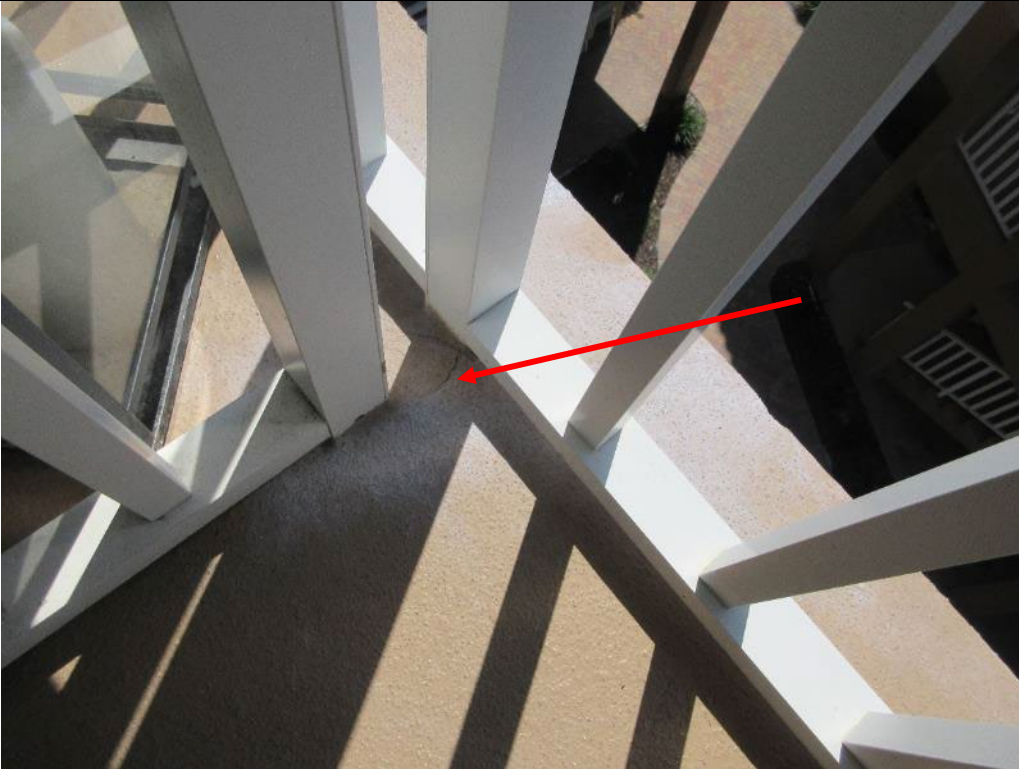
Photo 45. Failed Post Pocket and Waterproofing with Efflorescence C402

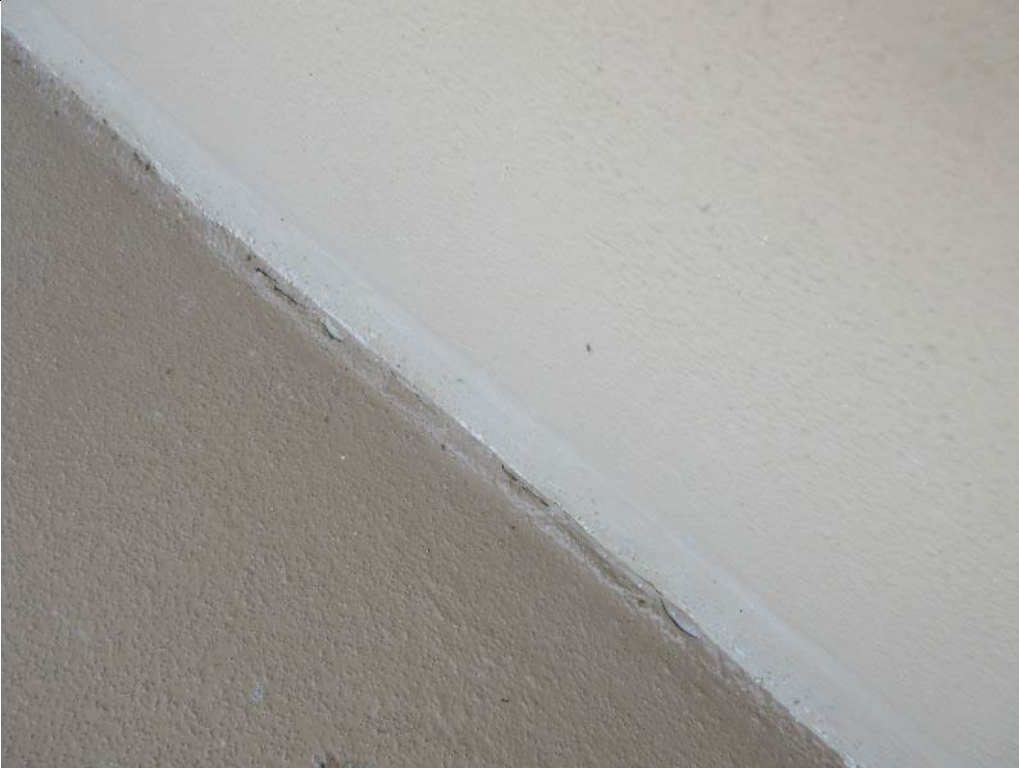
Photo 46. Typical Failed Floor to Wall Transition Sealant and Waterproofing

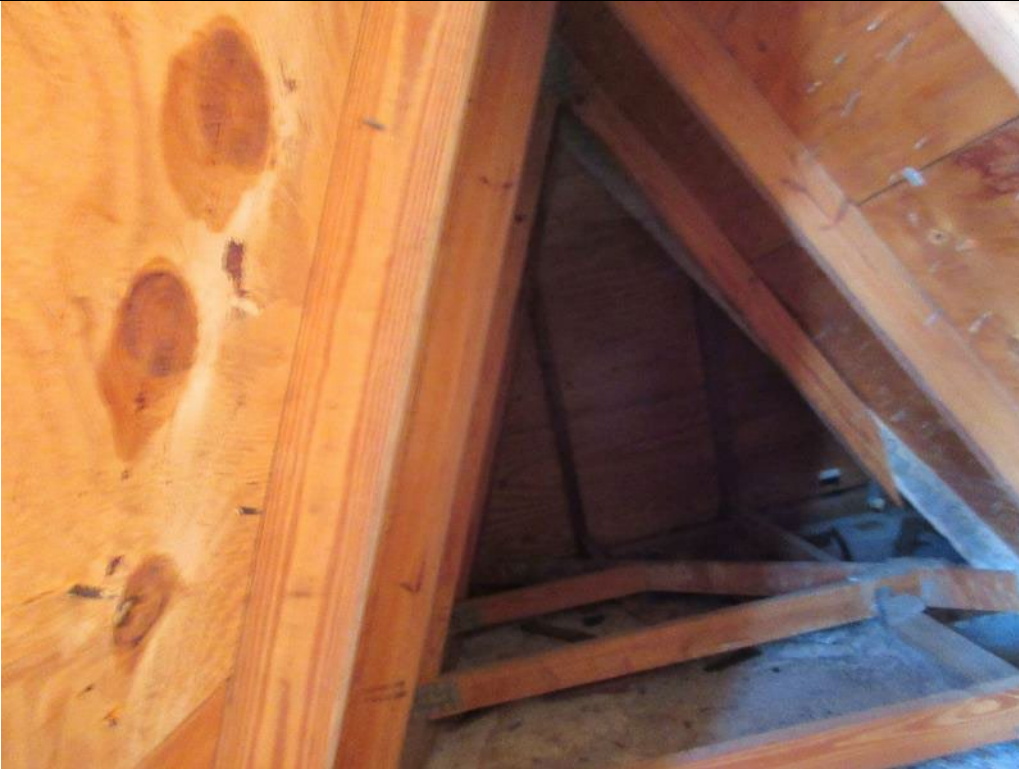
Photo 49. Typical Mansard Roof Trusses

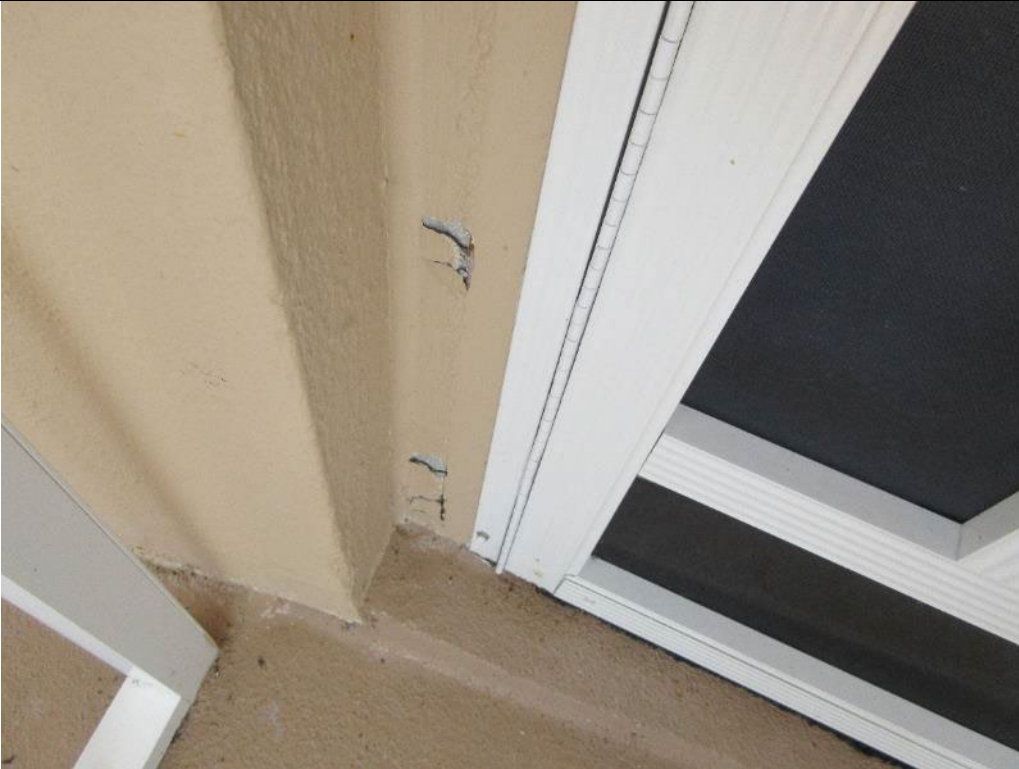
Photo 51. Damaged Stucco and Rusted Stucco Accessories Near C402

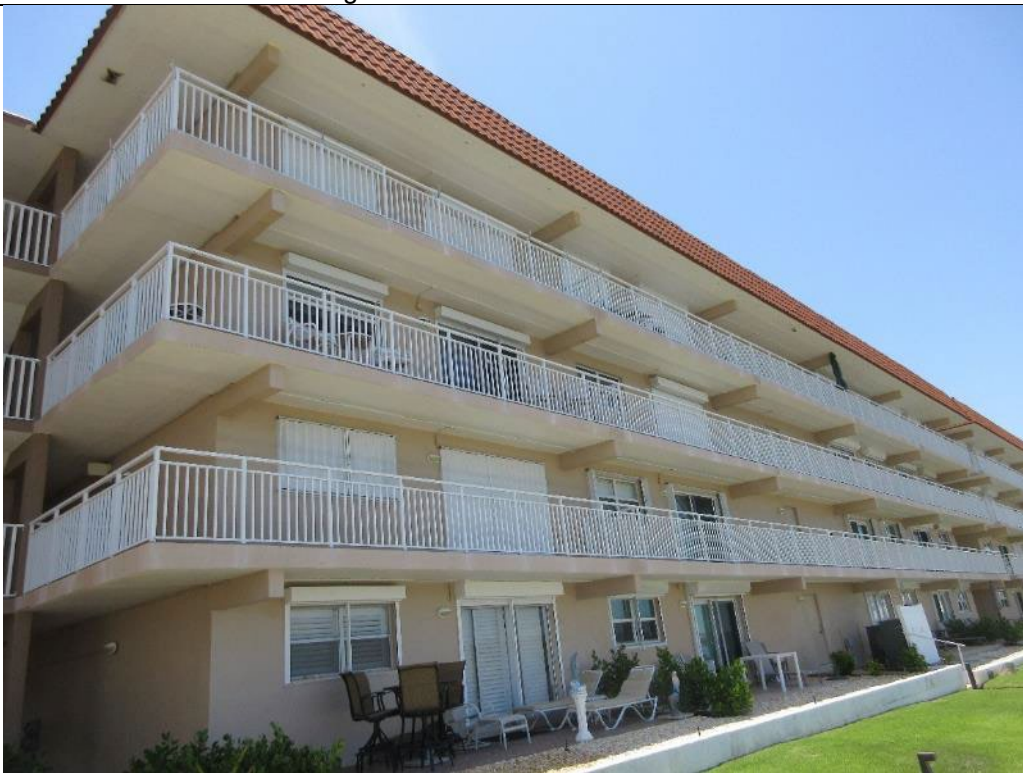
Photo 54. Rear Elevation Building D Overview

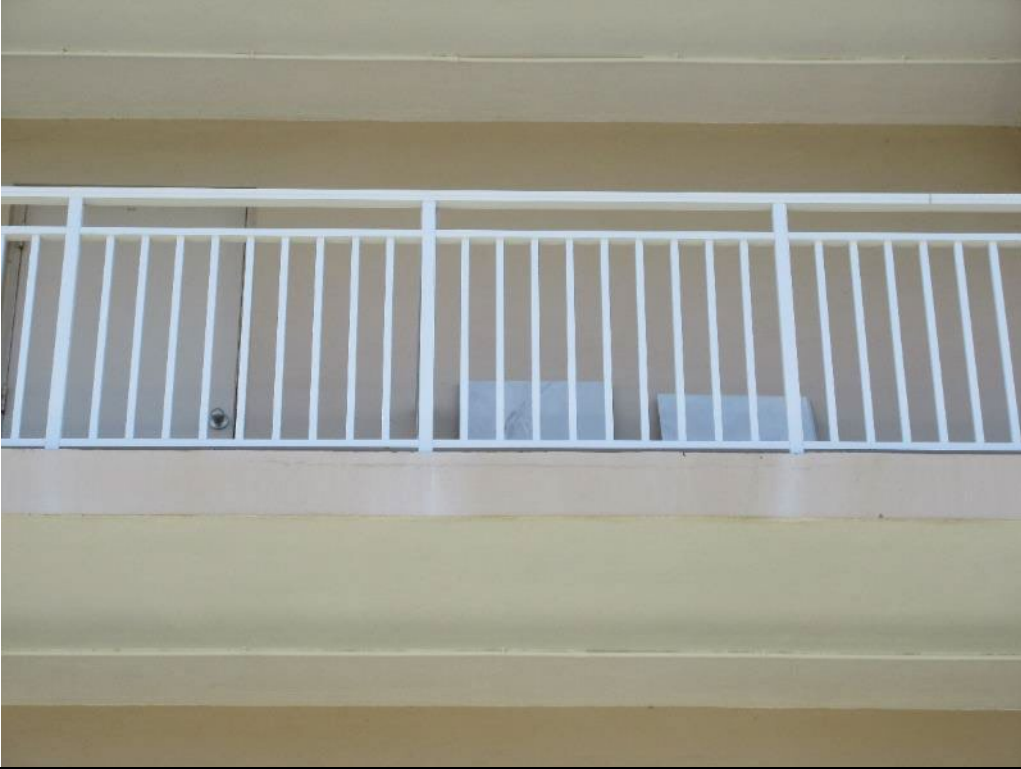
Photo 71. Crack and Spall at Slab Edge at 3<sup>rd</sup> Floor Lobby

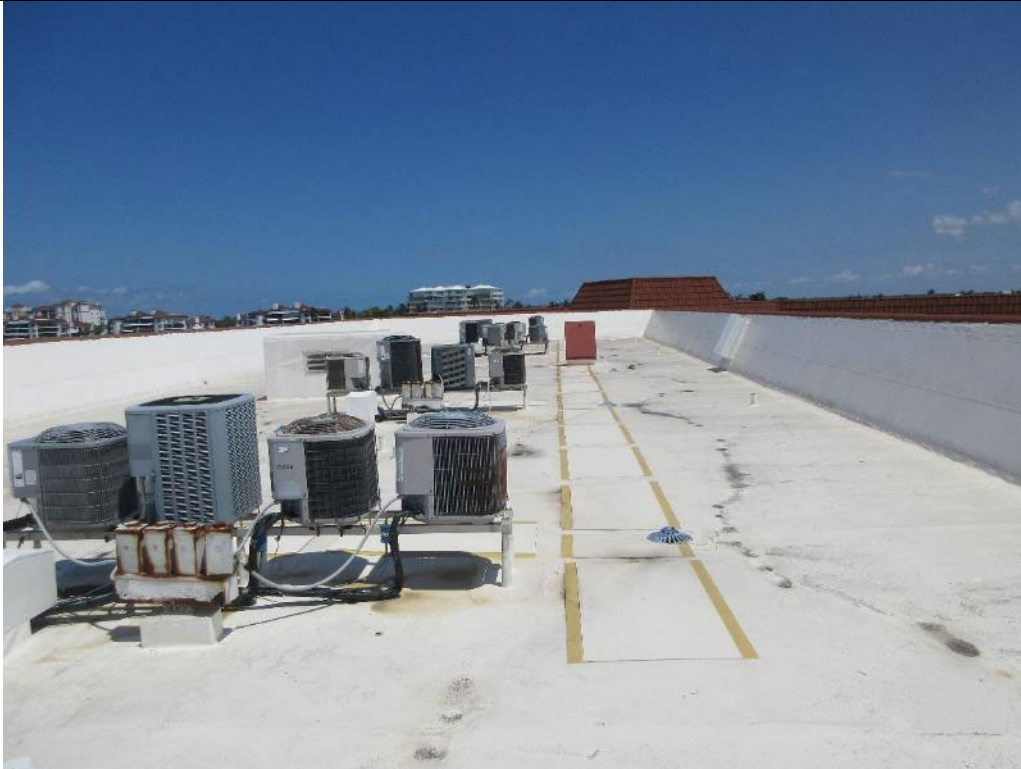
Photo 73. Typical Roof Overview Building S

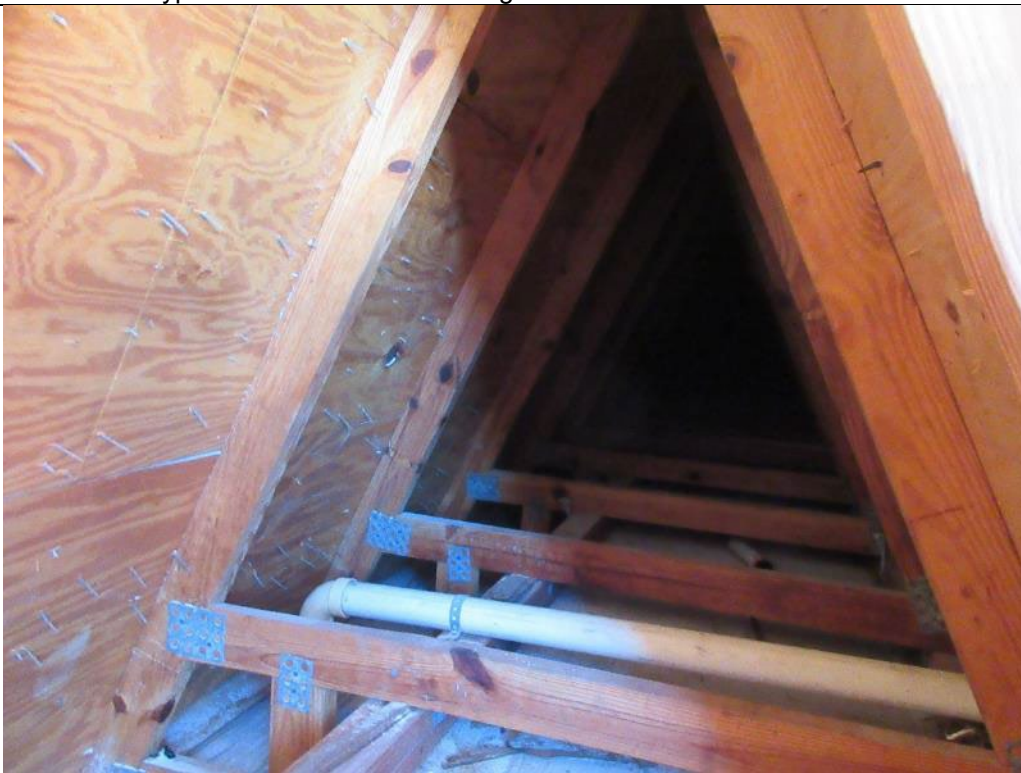
Photo 74. Typical Mansard Roof Framing Building D

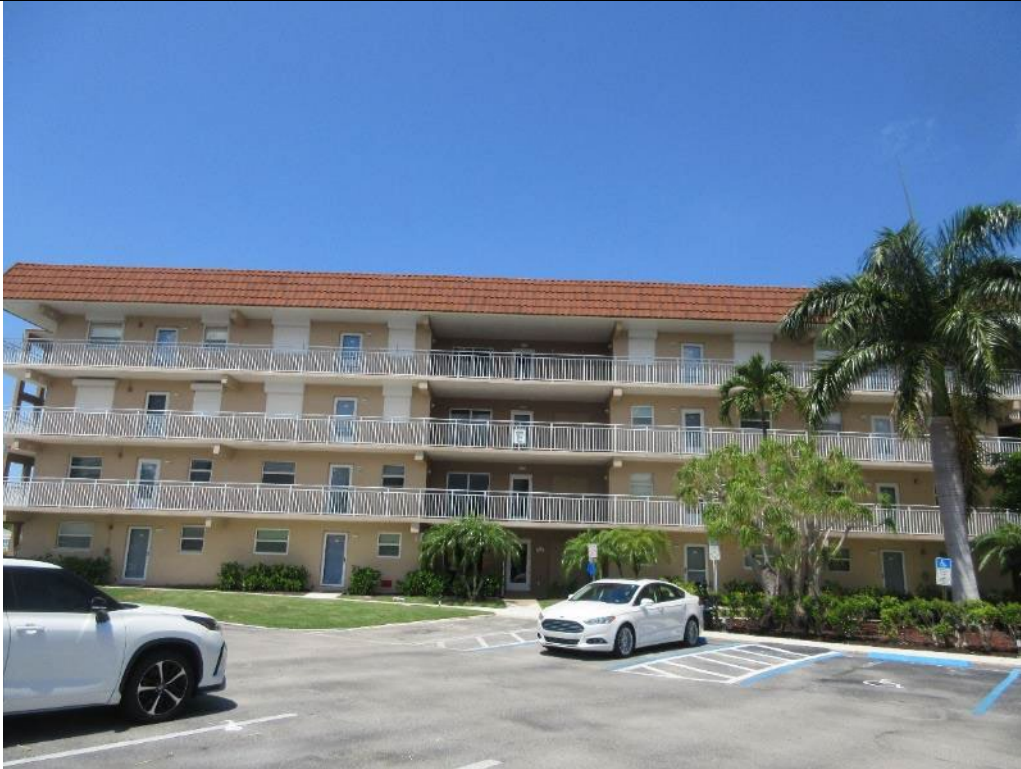
Photo 75. Building E Overview

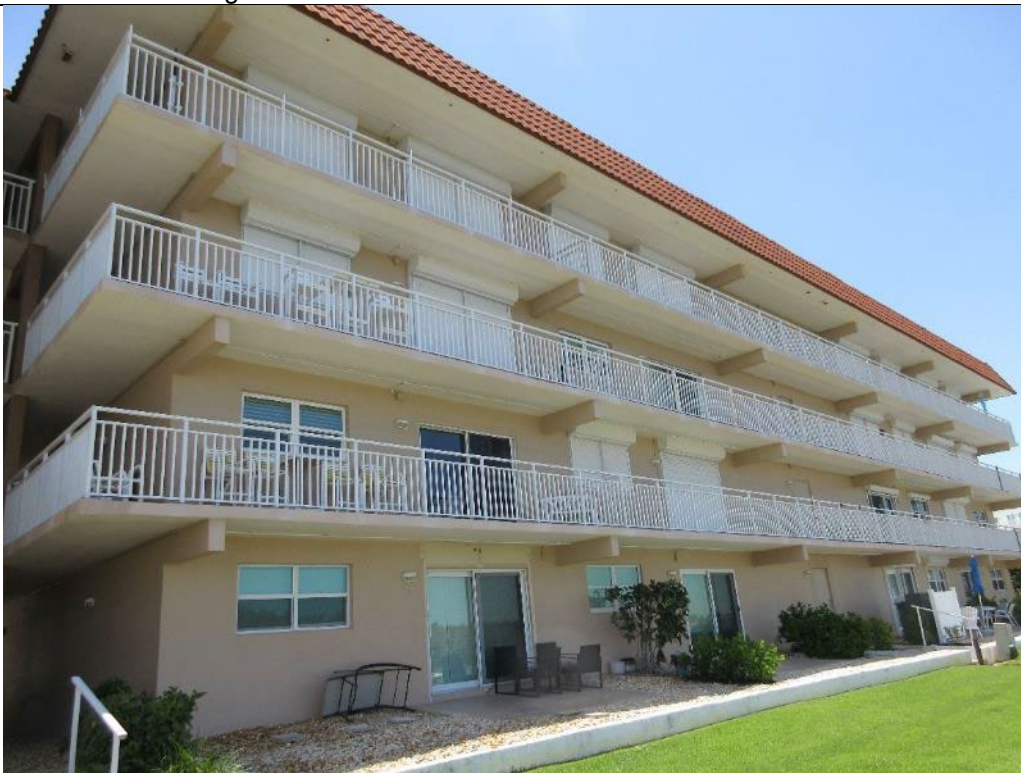
Photo 76. Building E Rear Overview

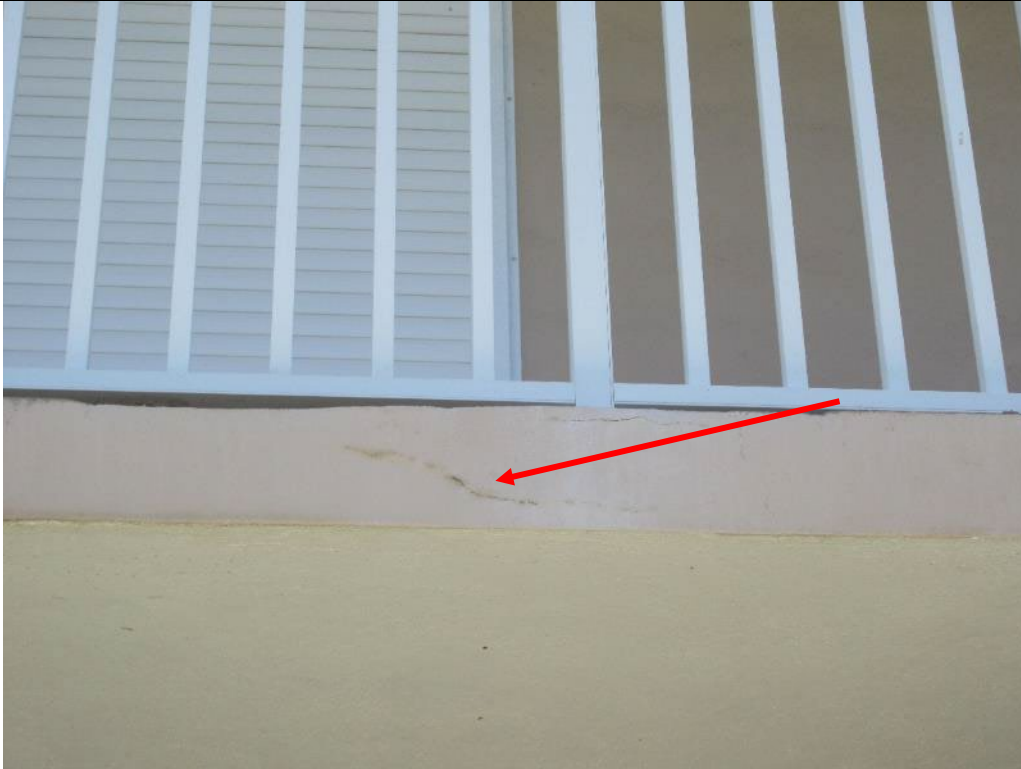
Photo 85. Spalling Concrete and Crack at Slab Edge E202

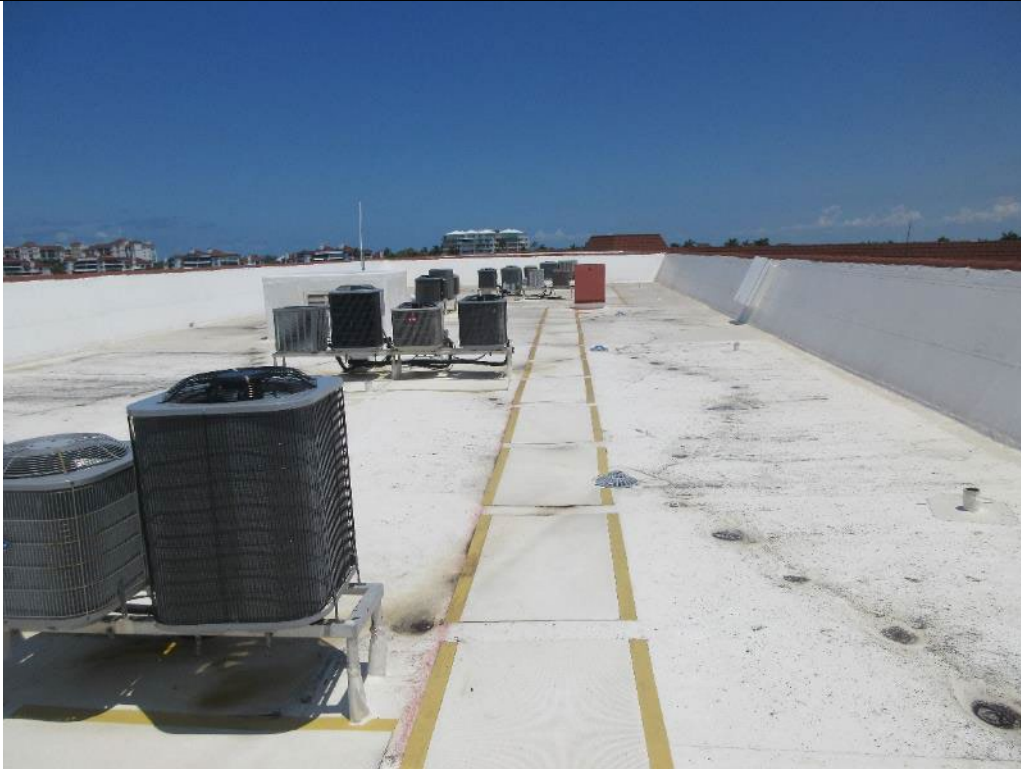
Photo 94. Typical Roof Overview Building E

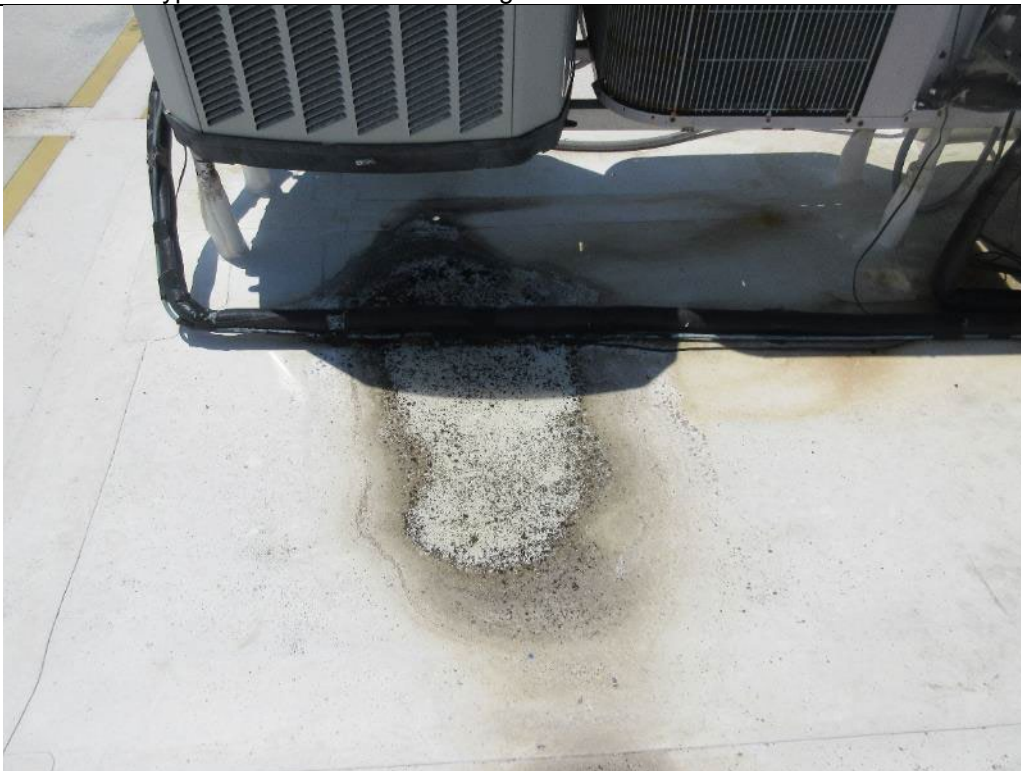
Photo 95. Isolated Ponding at Roof Building E

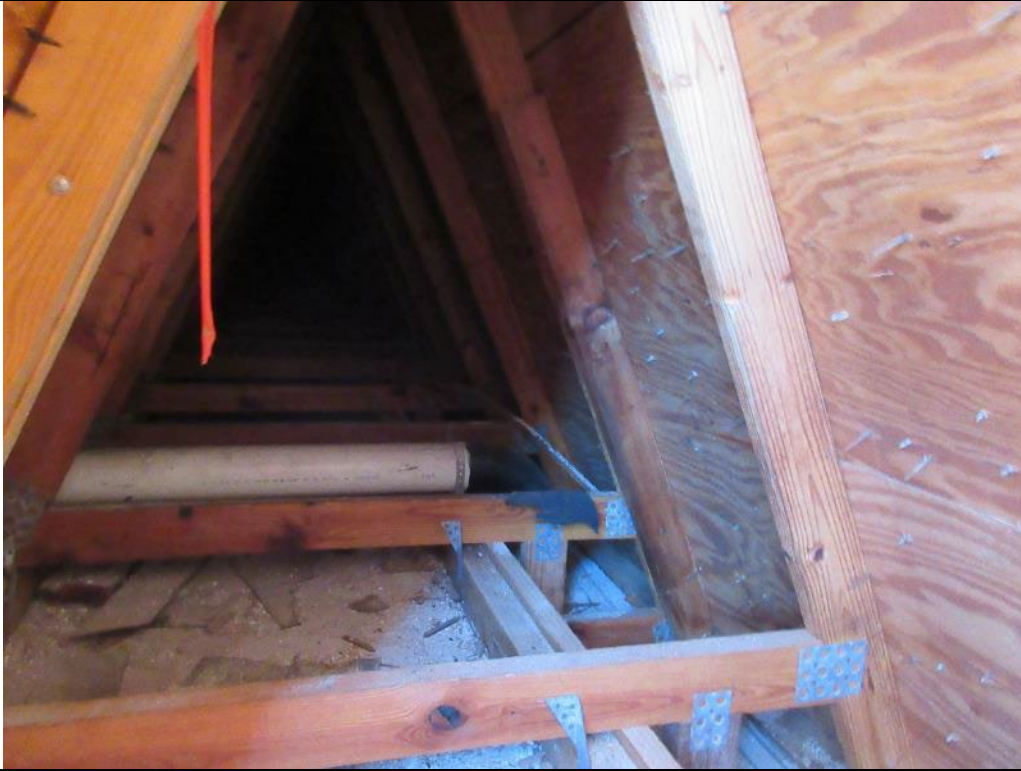
Photo 96. Typical Mansard Truss and Roof Deck Building E
