**Tradewinds Apartments of Marco Island  
Non-SIRS Components  
*Marco Island, FL***

Report #: 28334-3  
Beginning: January 1, 2024  
Expires: December 31, 2024

**RESERVE STUDY  
Update "With-Site-Visit"**

December 6, 2023

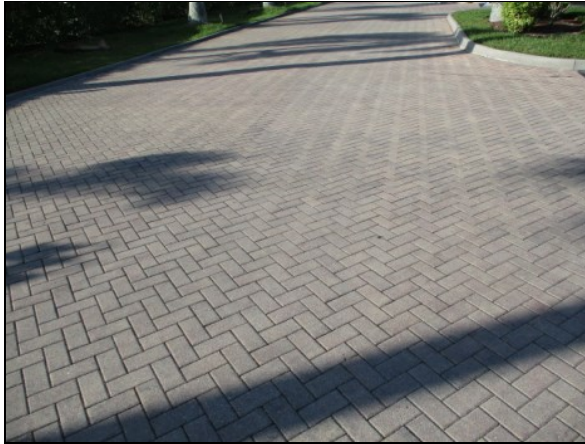
Useful Life:  
4 years

Remaining Life:  
0 years

Best Case: \$ 22,650

Worst Case: \$ 28,650

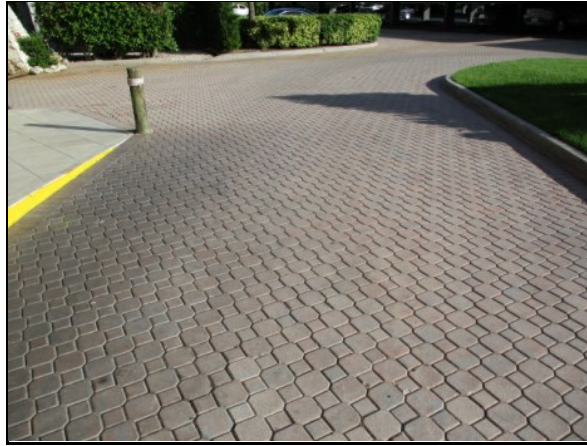
Useful Life:  
30 years

Remaining Life:  
11 years

Best Case: \$ 217,500

Worst Case: \$ 277,500

| # Component | Useful Life<br>(yrs) | Rem.<br>Useful Life<br>(yrs) | Current<br>Average<br>Cost |
|---|---|---|---|
| 2119 Roadway/Parking Pavers - Replace | 30 | 11 | \$247,500 |

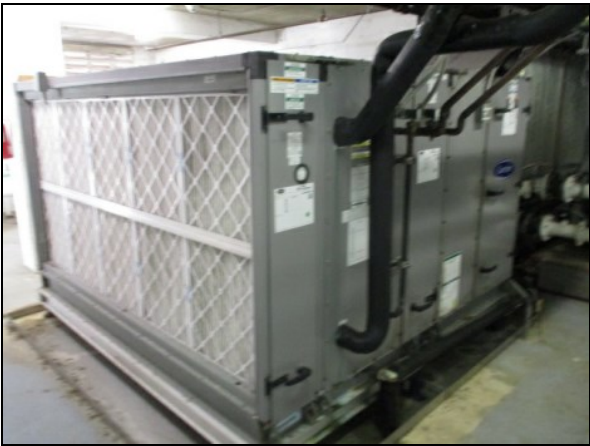
Useful Life:  
10 years

Remaining Life:  
5 years

Best Case: \$ 180,000

Worst Case: \$ 240,000

| # Component | Useful Life<br>(yrs) | Rem.<br>Useful Life<br>(yrs) | Current<br>Average<br>Cost |
|---|---|---|---|
| 2522 HVAC (Hallways) - Replace | 10 | 5 | \$210,000 |

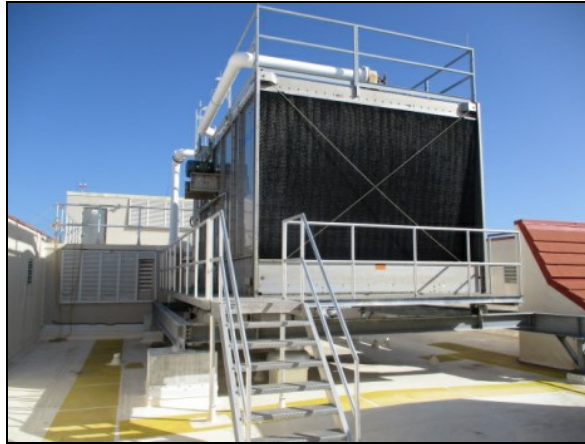
Useful Life:  
20 years

Remaining Life:  
14 years

Best Case: \$ 425,000

Worst Case: \$ 525,000

| # Component | Useful Life<br>(yrs) | Rem.<br>Useful Life<br>(yrs) | Current<br>Average<br>Cost |
|---|---|---|---|
| 2538 Cooling Tower - Replace | 20 | 14 | \$475,000 |

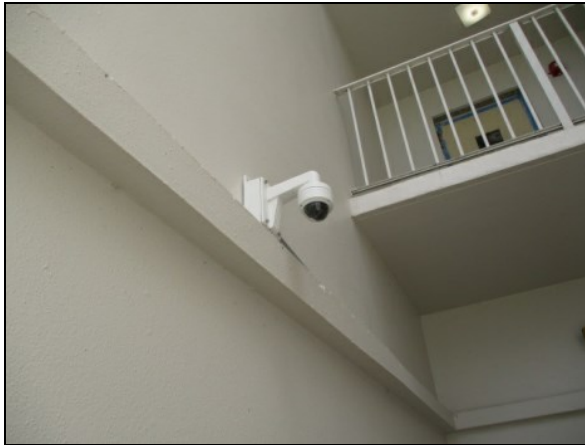
**Comp #: 2543 Surveillance System-Upgrade/Replace**

Comments: \*NOTE (2023): Per information provided, the client has entered into a maintenance/warranty agreement with a vendor for a 60-month term, during which the vendor will repair the system as part of the agreement. After that term ends, it is believed that the client/association will be financially responsible for system upgrades/replacements following that date. The remaining useful life

2022: DVR/NVR replacement and system expansion completed at an unreported cost (per information provided)

Security/surveillance systems should be monitored closely to ensure proper function. Whenever possible, camera locations should be protected and isolated to prevent tampering and/or theft. Typical modernization projects may include addition and/or replacement of cameras, recording equipment, monitors, software, etc. Unless otherwise noted, costs assume that existing wiring can be re-used and only the actual cameras and other equipment will be replaced. In many cases, replacement or modernization is warranted due to advancement in technology, not necessarily due to functional failure of the existing system. Keep track of any partial replacements and include cost history during future Reserve Study updates.

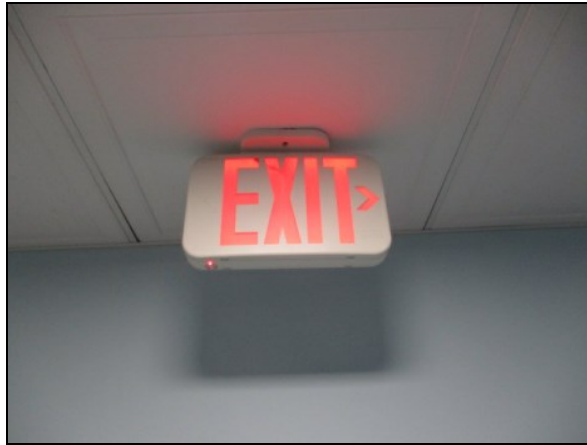
**Comp #: 2558 Exit/Emergency Fixtures - Replace**

Comments: Per information provided by management, a substantial quantity of signs were replaced during interior renovations (2021-2022) and any remaining amount is anticipated to be replaced as-needed. The remaining useful life of this component has been adjusted to coordinate with future interior renovation timelines.

Exit signs and/or emergency lights were not tested for functionality during site inspection. Replacement of individual signs can be included within the general maintenance and repair category of the Operating budget. Large-scale replacement of most (or all) fixtures may be warranted at some point and should ideally be coordinated with other life-safety components (i.e. fire alarm components) or with aesthetic projects (such as painting or light replacement). Useful life is based primarily on normal expectations for service/performance life in this location. Unless otherwise noted, remaining useful life expectancy is based primarily on original installation or last replacement/purchase date, our experience with similar systems/components, and assuming normal amount of usage and good preventive maintenance. Funding shown below assumes replacement with fixtures comparable to those currently in place. However, there is a wide variety of fixture styles available, with a wide range of associated costs. As such, the Client should track and report replacement costs as well as any future upgrade anticipations. This component should then be re-evaluated during future Reserve Study updates based on the most current information available at that time.

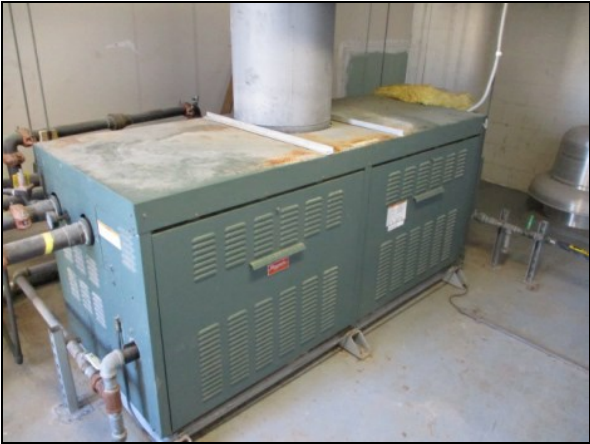
**Comp #: 2571 Boiler - Replace**  
Location: Mechanical room (rooftop)  
Funded?: Yes.  
History: Replaced in 2015 at a cost of \$30,900 (per information provided)  
Comments: Manufacturer: Raypak  
Model: H4-1631A  
Input: 1,630,000 BTU

Boiler should be inspected and evaluated regularly by servicing vendor. Lower than average use expected in southeastern climates. In some cases, replacement is warranted due to lack of available replacement parts, or to upgrade to more efficient technology. Treat routine repairs/maintenance as an Operating expense. Plan for replacement at the typical service life expectancy indicated below. Useful life can often be extended with proactive service and maintenance. Unless otherwise noted, funding for system with same size/capacity as the current system. Minimal or no subjective/aesthetic value for this component. Useful life is based primarily on normal expectations for service/performance life in this location. Unless otherwise noted, remaining useful life expectancy is based primarily on original installation or last replacement/purchase date, our experience with similar systems/components, and assuming normal amount of usage and good preventive maintenance.

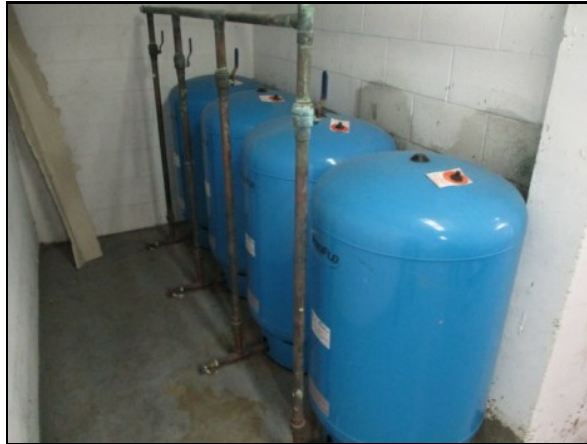
**Comp #: 2573 Bladder/Pressure Tanks - Replace****Quantity: (4) Pressure Tanks**

Water storage tanks should be inspected for leaks and other problems routinely by servicing vendor or maintenance staff. Small repairs and cleaning should be considered an Operating expense and conducted as needed. Plan to replace at the approximate interval shown below, ideally coordinated with replacement of the boiler/hot water heater itself in order to achieve better pricing and minimize system downtime. Minimal or no subjective/aesthetic value for this component. Useful life is based primarily on normal expectations for service/performance life in this location. Unless otherwise noted, remaining useful life expectancy is based primarily on original installation or last replacement/purchase date, our experience with similar systems/components, and assuming normal amount of usage and good preventive maintenance.

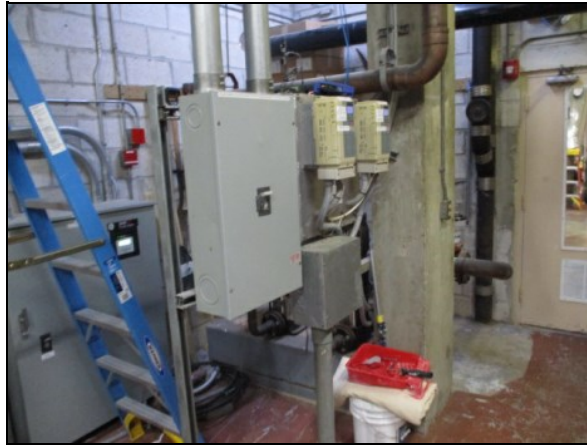
**Comp #: 2575 Domestic Water System - Replace****Quantity: (1) Duplex System**

History: Replaced in 2015 at a cost of \$15,800 (per information provided)

Minimal or no subjective/aesthetic value for this component. Useful life is based primarily on normal expectations for service/performance life in this location. Total life span can vary based on level of use, preventive maintenance, quality of materials and installation, etc. As such, water pumps and control system should be inspected regularly and repaired as-needed by servicing vendor or maintenance staff to ensure proper function and optimal performance. Pumps should have an electronic controller or variable frequency drives to optimize output, minimize energy consumption and prolong life expectancy. Minor repairs such as pump motor replacements and electronic system parts should be considered an Operating expense. Unless otherwise noted, remaining useful life expectancy is based primarily on original installation or last replacement/purchase date, our experience with similar systems/components, and assuming normal amount of usage and good preventive maintenance. Cost estimates shown below anticipate replacement with a similar sized system as currently in place. However, any anticipated changes should be reported by the Client and this component should be re-evaluated during future Reserve Study updates based on the most current information available at that time.

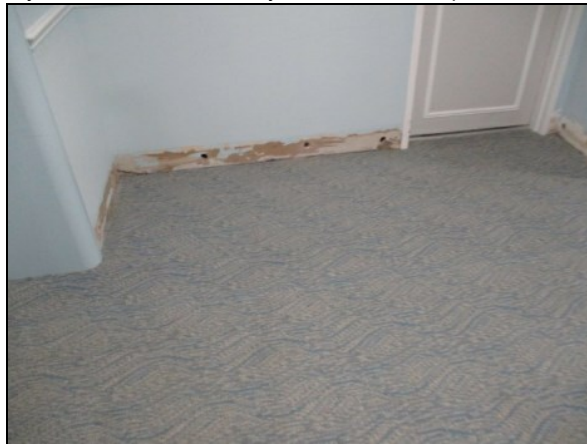
2023: Leak/drywall repairs to be conducted at an unreported cost (per information provided/evident conditions)

Good condition: Interior areas determined to be in good condition typically exhibit few significant marks, scuffs or other aesthetic concerns. Color is consistent and compatible with other finishes/furnishings and maintaining good standards in the common areas.

Regular cycles of professional painting are recommended to maintain appearance. Small touch-up projects can be conducted as needed as a maintenance expense, but comprehensive painting of interior areas will restore a consistent look and quality to all areas. Best practice is to coordinate at same time as other interior projects (flooring, furnishings, lighting, etc.) whenever possible to minimize downtime and maintain consistent quality standard. Based on evident conditions and/or project history provided during this engagement, we recommend repainting at the approximate interval shown below. Unless otherwise noted, cost estimates below are intended for painting only and not inclusive of any extensive wall repairs/renovations (such as trim work, etc.).

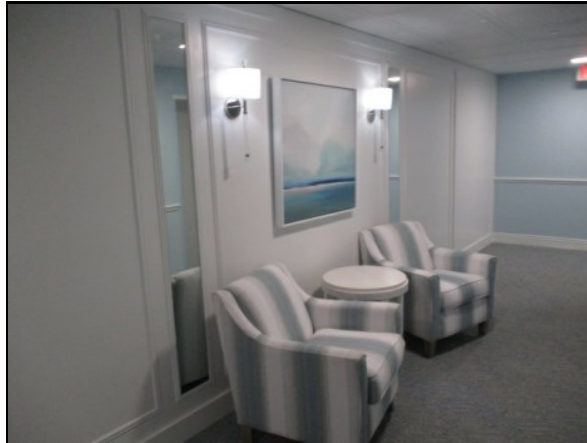
**Comp #: 2705 Interior Lights - Replace**

History: Replaced in 2021-2022 at a cost of \$45,000 (per information provided)

Comments: Good condition: Interior lights determined to be in good condition typically exhibit little to no signs of physical wear and tear, and style/fixture type is appropriate for the standards of the property.

Light fixtures should be inspected, repaired and bulbs replaced as needed through the Operating budget. Over time, the fixtures will require replacement for either functional or aesthetic reasons. Best practice is to coordinate at same time as other interior projects (especially painting or wallcovering replacement) whenever possible to minimize downtime and maintain consistent aesthetic standard. Timing of replacements is ultimately subjective to the Client. A wide variety of fixture styles is available, and cost can vary significantly based on the fixture chosen for replacement. Unless otherwise noted, cost estimates shown below assume replacement with comparable quality as existing fixtures and are based on our experience with similar properties.
