# JMC Engineering Inc.

VILLE DE MARCO WEST, A CONDOMINIUM, INC.  
1200-1208 Edington Place  
Marco Island, FL 34145

Reference: MILESTONE PHASE 1 INSPECTION REPORT  
Ville De Marco West, A Condominium, Inc.  
JMC Project Number: 119BPM.12

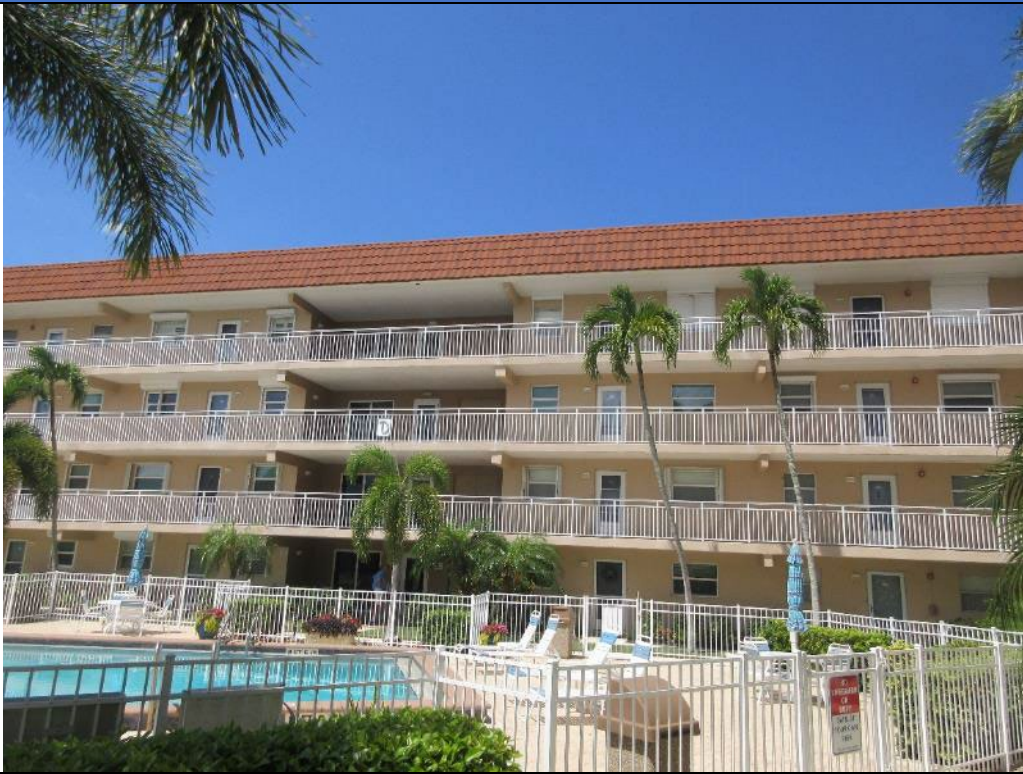
Photo 53. Overview Building D
